EVALUATION OF POLYETHYLENE TAPE COATING/MILD STEEL BOND FAILURE ON
THE SOIL-TO-AIR REGION OF A CRUDE OIL PIPELINE

A PROJECT PRESENTED TO THE
DEPARTMENT OF MECHANICAL ENGINEERING,
FACULTY OF ENGINEERING,
UNIVERSITY OF BENIN, BENIN CITY, EDO STATE, NIGERIA

IN PARTIAL FULFILMENT OF THE REQUIREMENT FOR THE AWARD OF MASTER OF
ENGINEERING (IN INDUSTRIAL METALLURGY AND CORROSION MANAGEMENT)

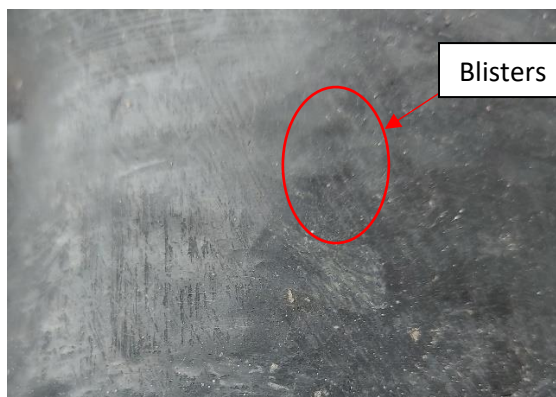
Specimen 1a (Above ground) External Tape coating surface

Specimen 1a external Tape coating surface shows minimal degradation (surface abrasion) and blisters while Specimen 1b external Tape coating surface shows more degradation and blisters compared to specimen 1a. Specimen 1a & 1b shows some degree of rust with negligible concerns on pipeline metal surface underneath the tape coating.

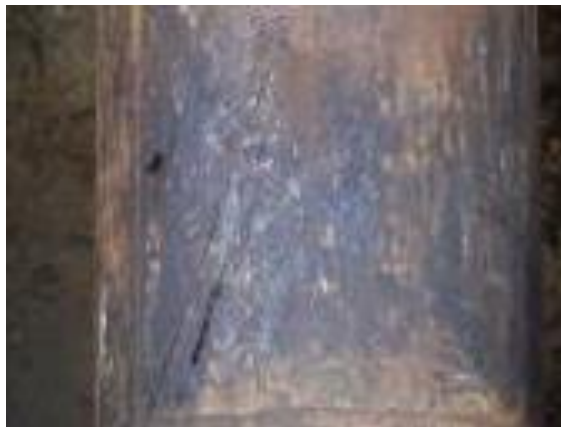
Specimen 2a (Above ground) External metal surface underneath Tape coating

Specimen 2a pipeline metal surface underneath the tape coating shows some minimal localized rust while Specimen 2b shows more general rust on the pipeline metal surface.

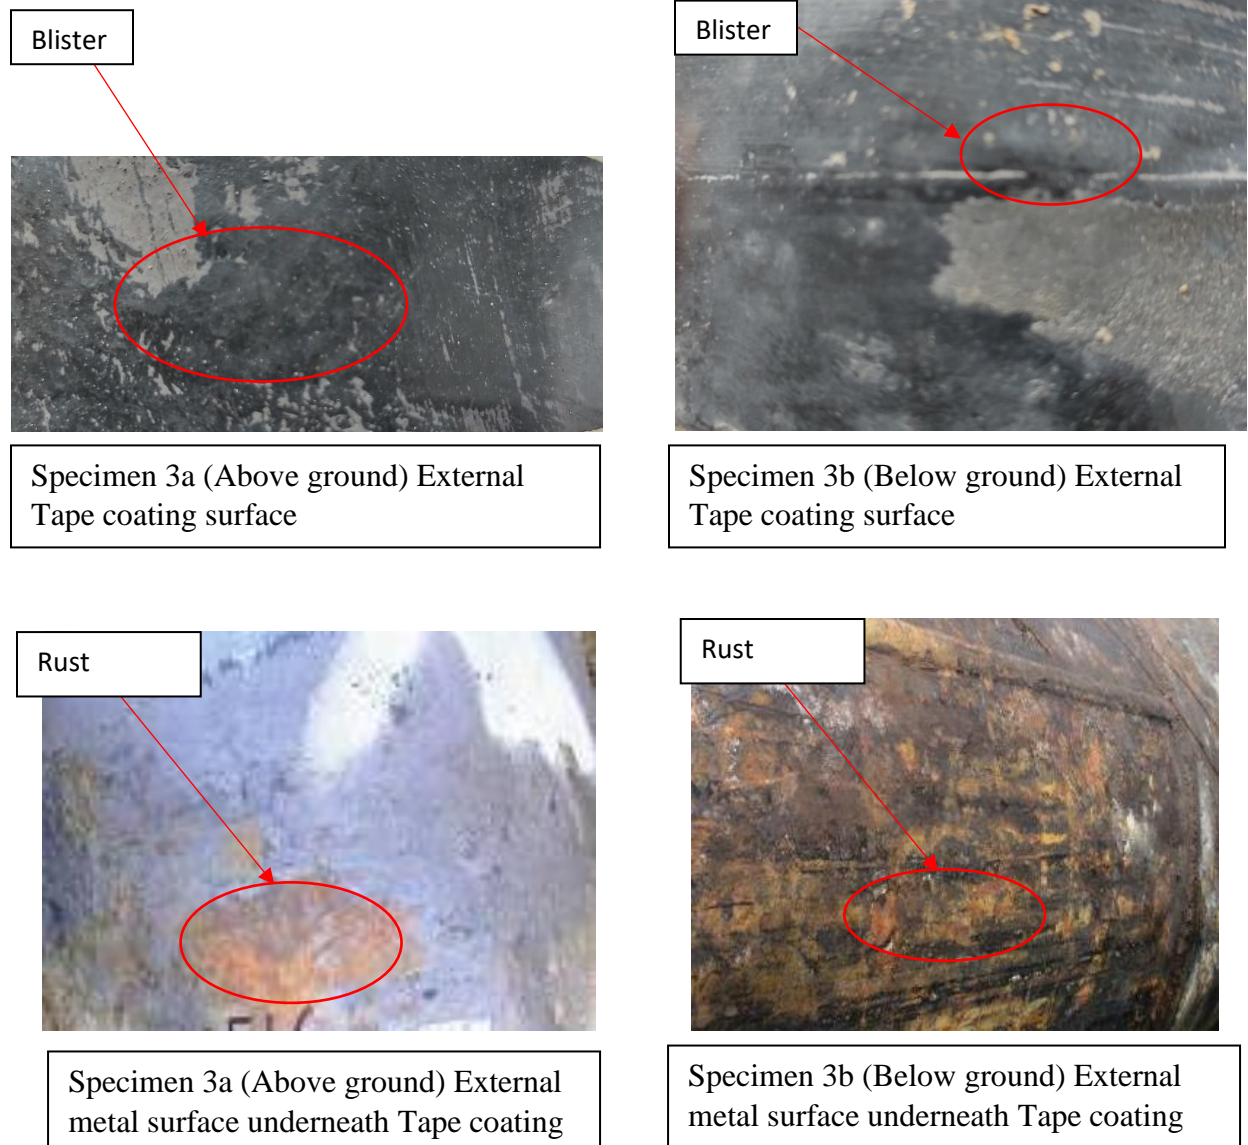
Figure 4.3 Presents the Close Visual Examination of Pipeline 3:

Specimen 3a external tape coating surface was observed with more blisters and general degradation while Specimen 3b external tape coating surface was observed with more blisters and more severe degradation when compared with specimen 3a.

Specimen 3a pipeline metal surface underneath the tape coating shows localized rust while Specimen 3b shows very severe general rusting on the pipeline metal surface.

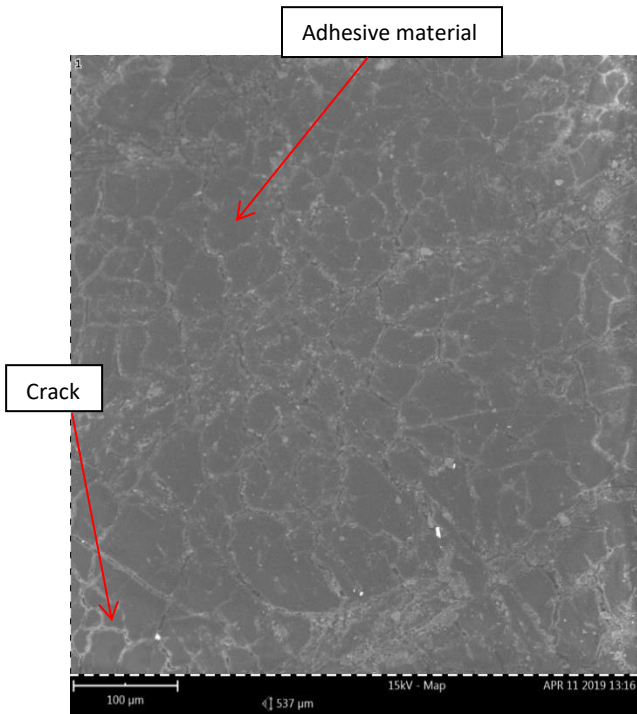
Table 4.2. Chemical composition of specimen 1a

Tape specimen 1a shows no significant evidence of corrosion product on surface of tape/pipe interface. Weblike cracks on the tape surface indicates general adhesive degradation resulting in shrinkage, embrittlement due to long exposure to the elements.
