**CHARACTERISTICS OF ROAD ACCIDENTS DUE TO ROAD FAILURES ALONG
BENIN-AUCHI ROAD (EGBA COMMUNITY)**

**A THESIS SUBMITTED TO THE DEPARTMENT OF STRUCTURAL
ENGINEERING IN PARTIAL FULFILLMENT OF THE REQUIREMENT FOR
THE AWARD OF BACHELOR OF ENGINEERING (B.ENG) STRUCTURAL
DEGREE**

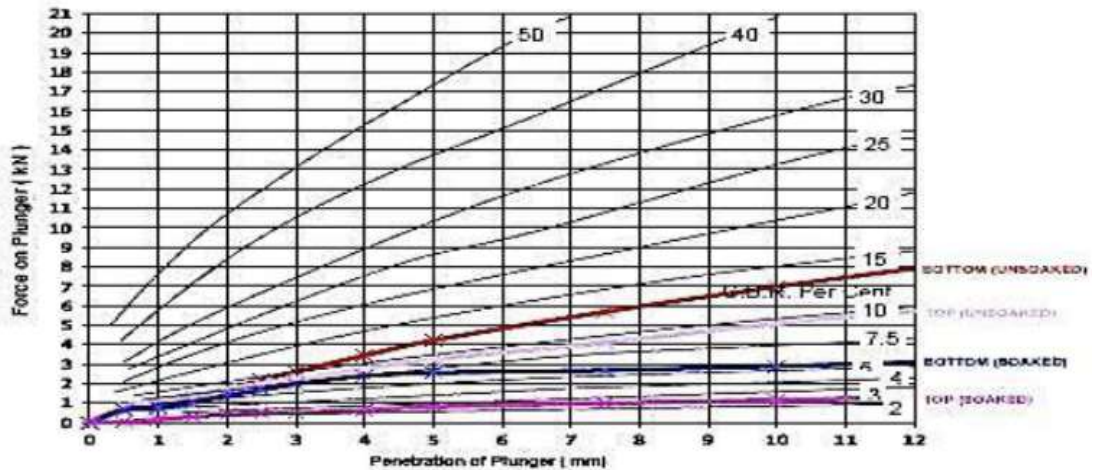
Figure 4.11: California Bearing Ratio for Point B

UNSOAKED		SOAKED	
	2.5mm	5.0mm	2.5mm	5.0mm
BOTTOM	16.82	21.1529	12.6352	12.8232
TOP	14.9475	16.2308	3.71624	4.11001

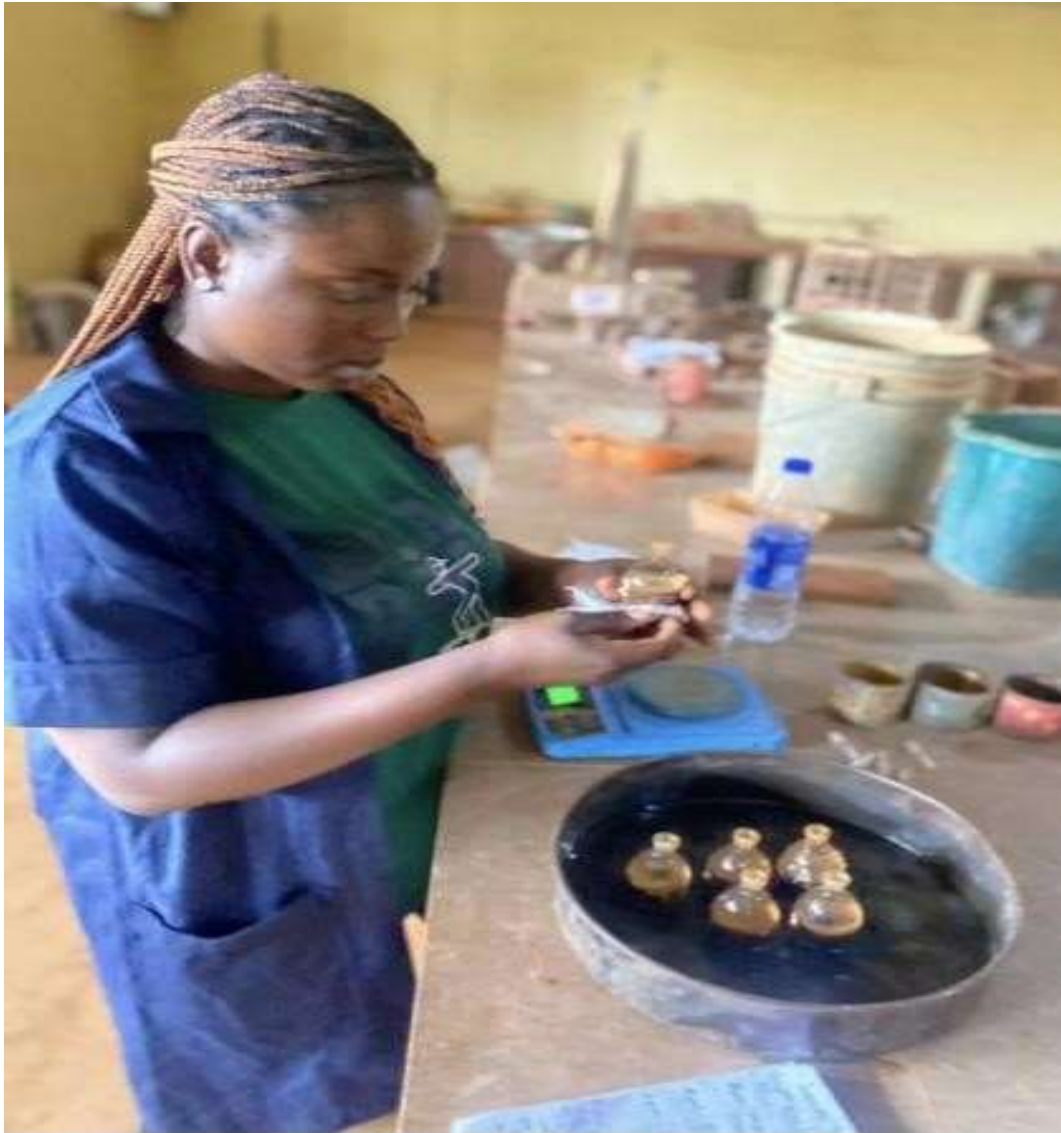
SPECIFIC GRAVITY TEST IN PROGRESS

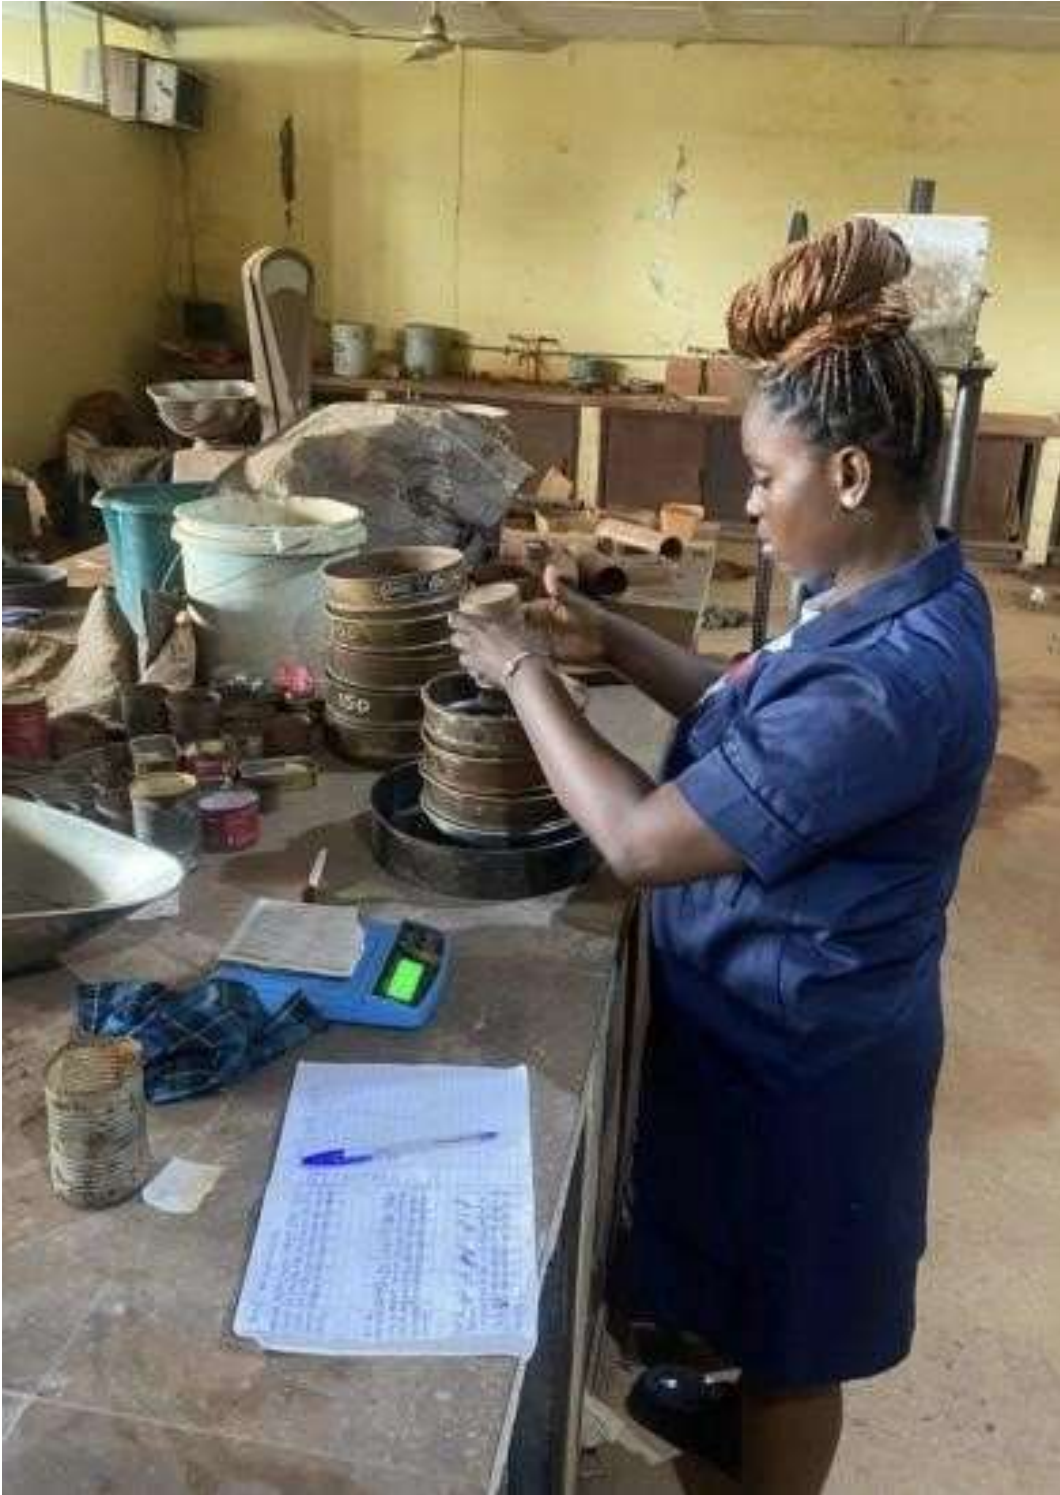
SIEVE ANALYSIS TEST IN PROGRESS

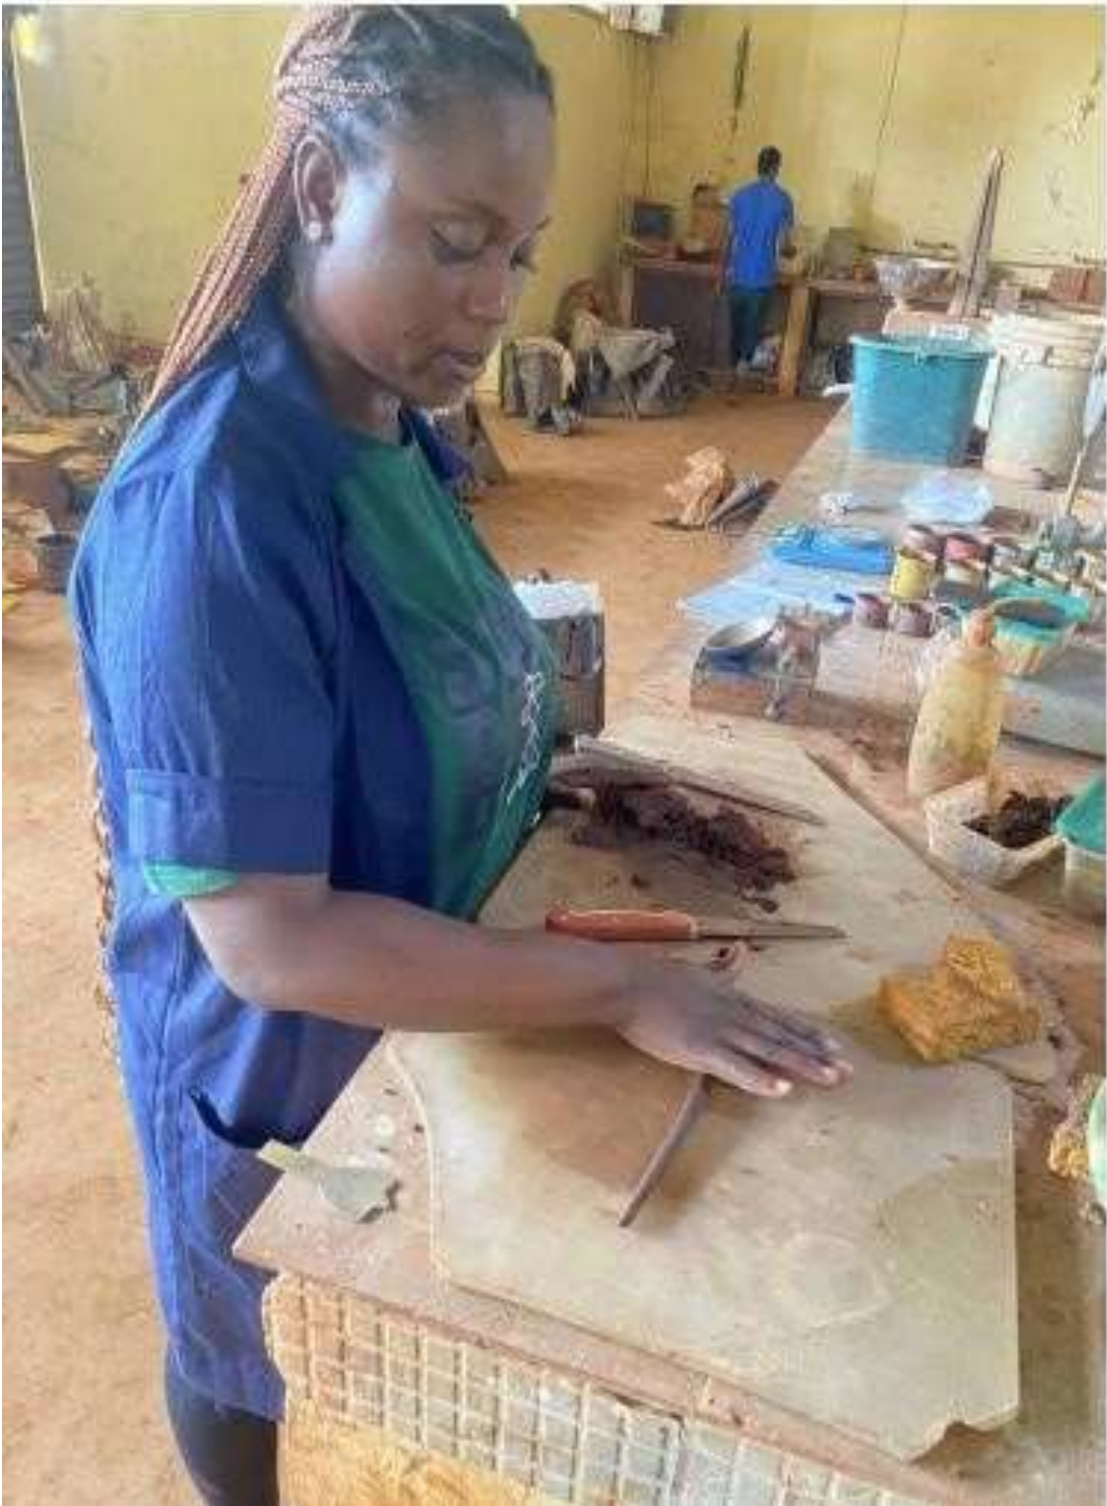
PLASTIC LIMIT TEST IN PROGRESS

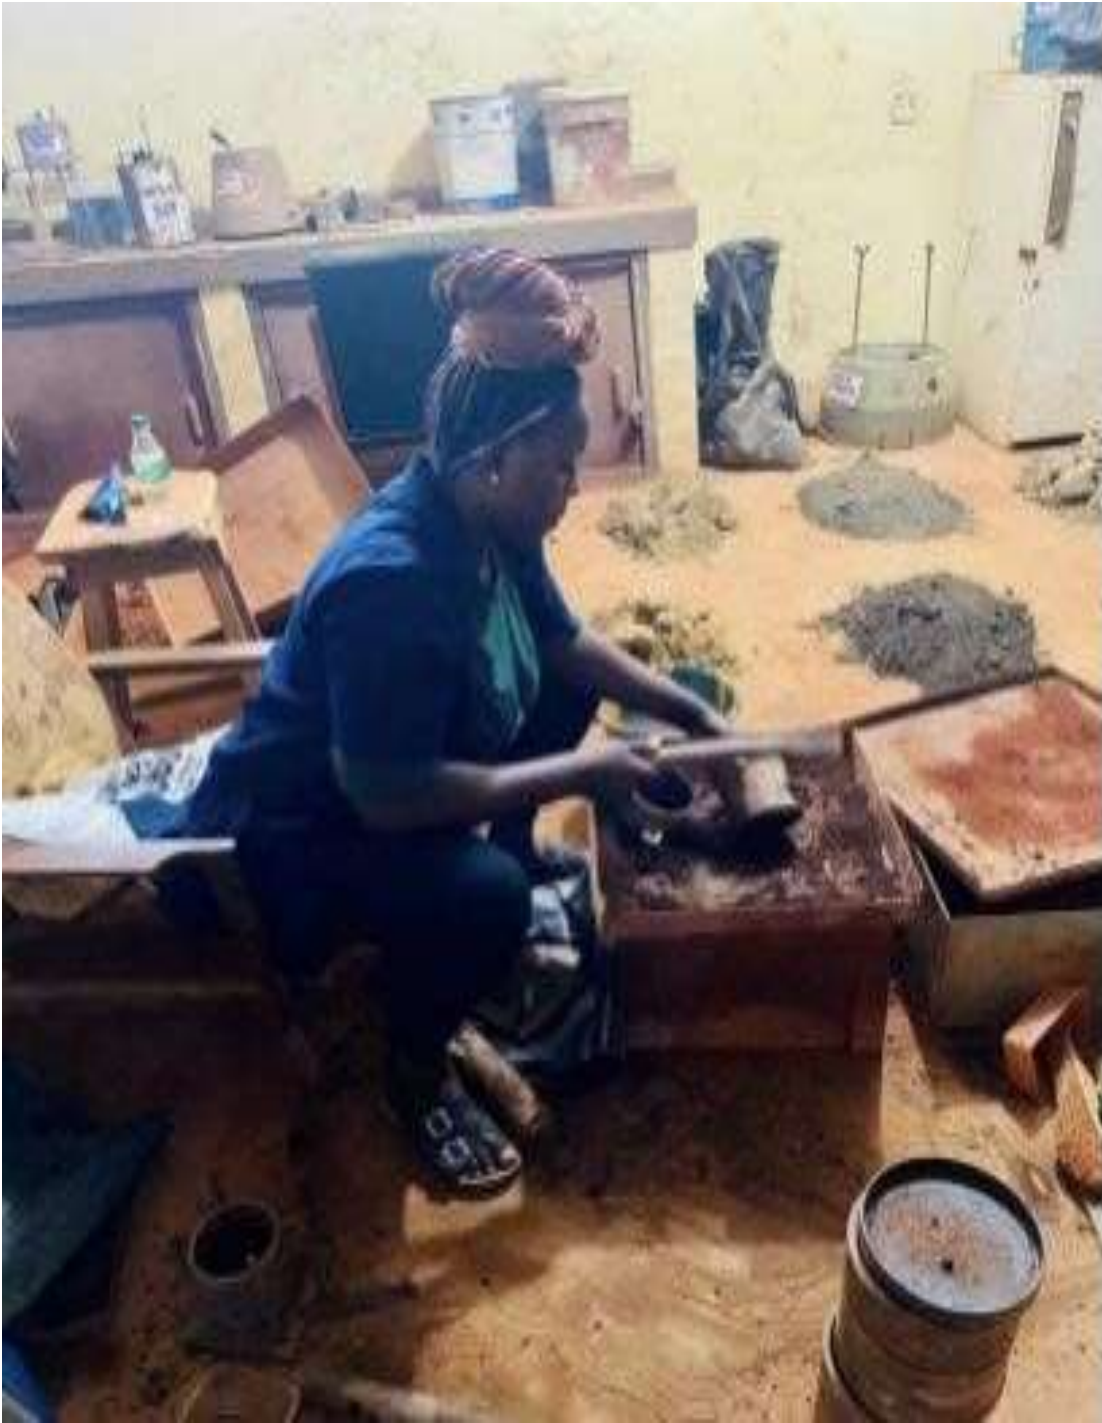
COMPACTION TEST IN PROGRESS

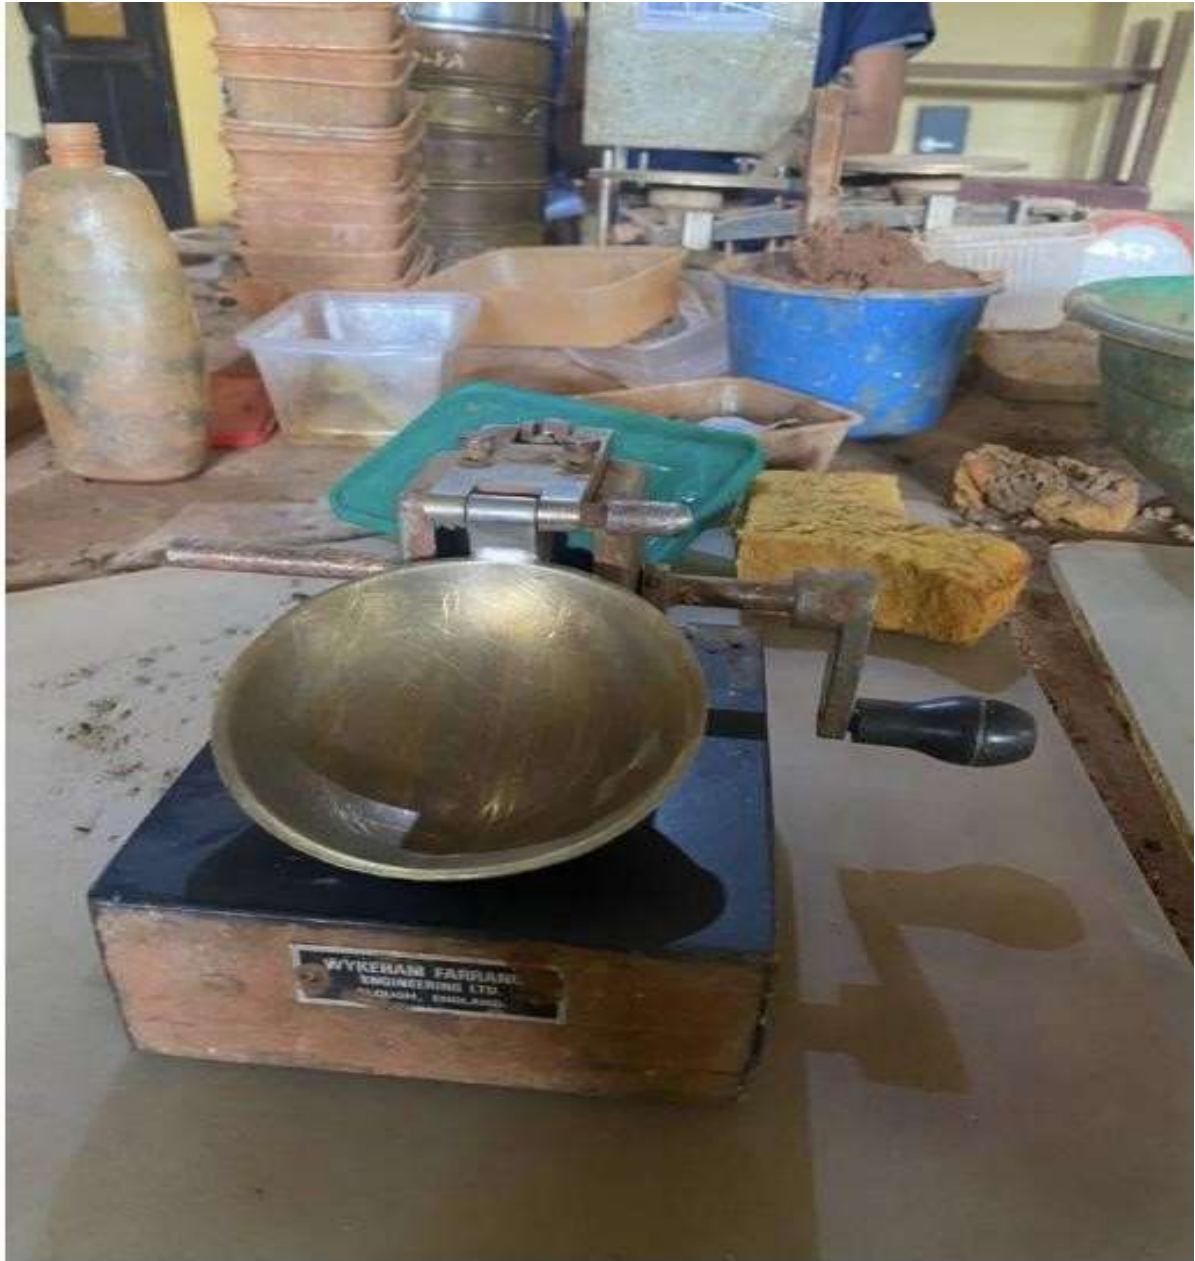
THE CASAGRANDE

1. Fill the cup with soil paste.
2. Using a normal grooving tool, cut a groove in the center of the dirt paste.
3. Using the crank-operated can, lift and drop the cup from a height of 10mm. Take note of the number of strokes required to close a distance of 12.7mm along the bottom of the groove.
4. Repeat the processes at least five times with different moisture contents of the same soil.
5. On a semi-logarithmic graph, plot the soil moisture content in percent and the matching number of blows. Draw the straight line that best fits the plotted points.

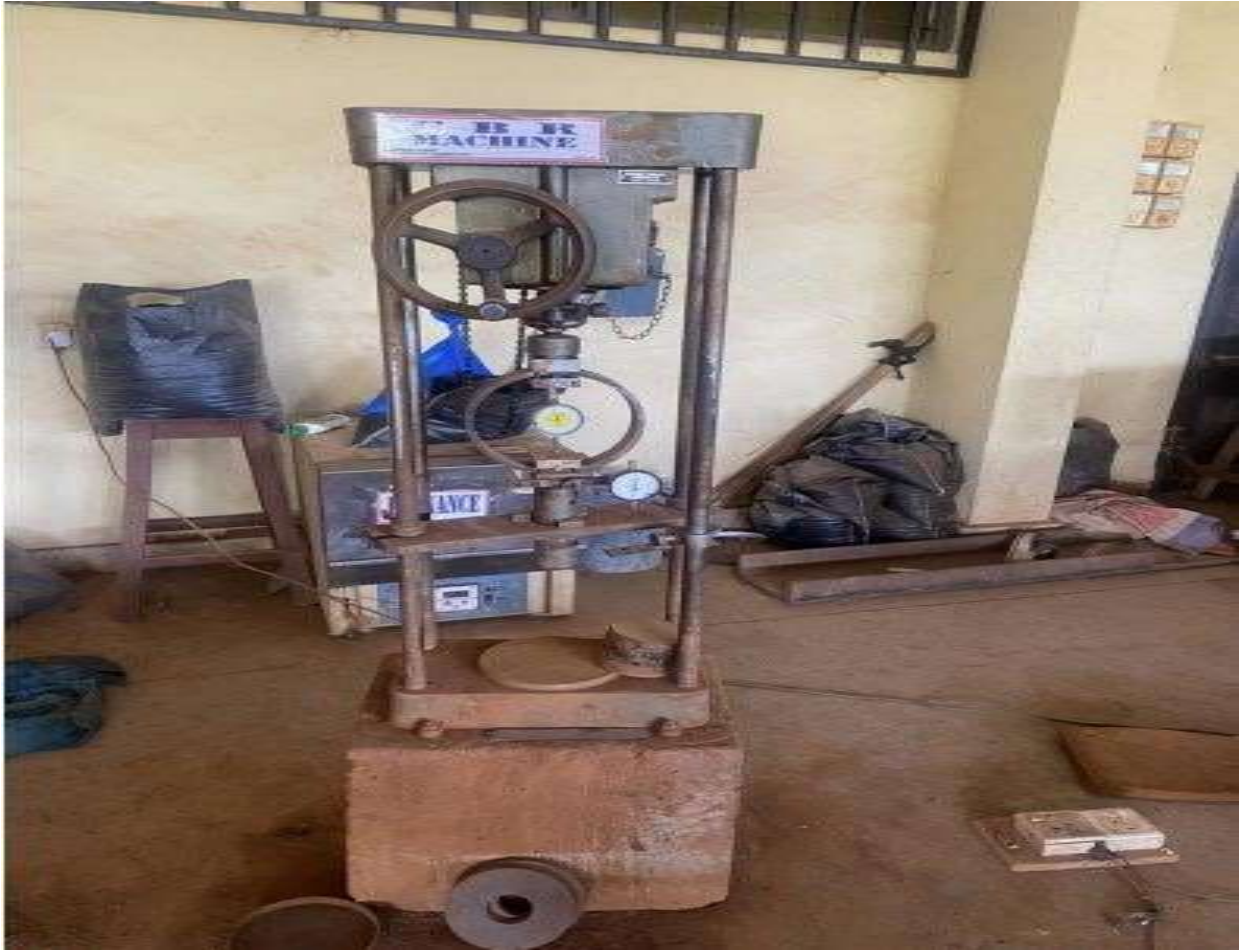
CBR MACHINE
