**EVALUATION OF THE CAUSES OF BUILDING COLLAPSE IN
EDO STATE, NIGERIA**

**A PROJECT SUBMITTED IN PARTIAL FULFILLMENT FOR THE
AWARD OF BACHELOR'S DEGREE IN ENGINEERING (B.ENG)**

**DEPARTMENT OF CIVIL ENGINEERING,
FACULTY OF ENGINEERING,
UNIVERSITY OF BENIN,**

September, 2021.

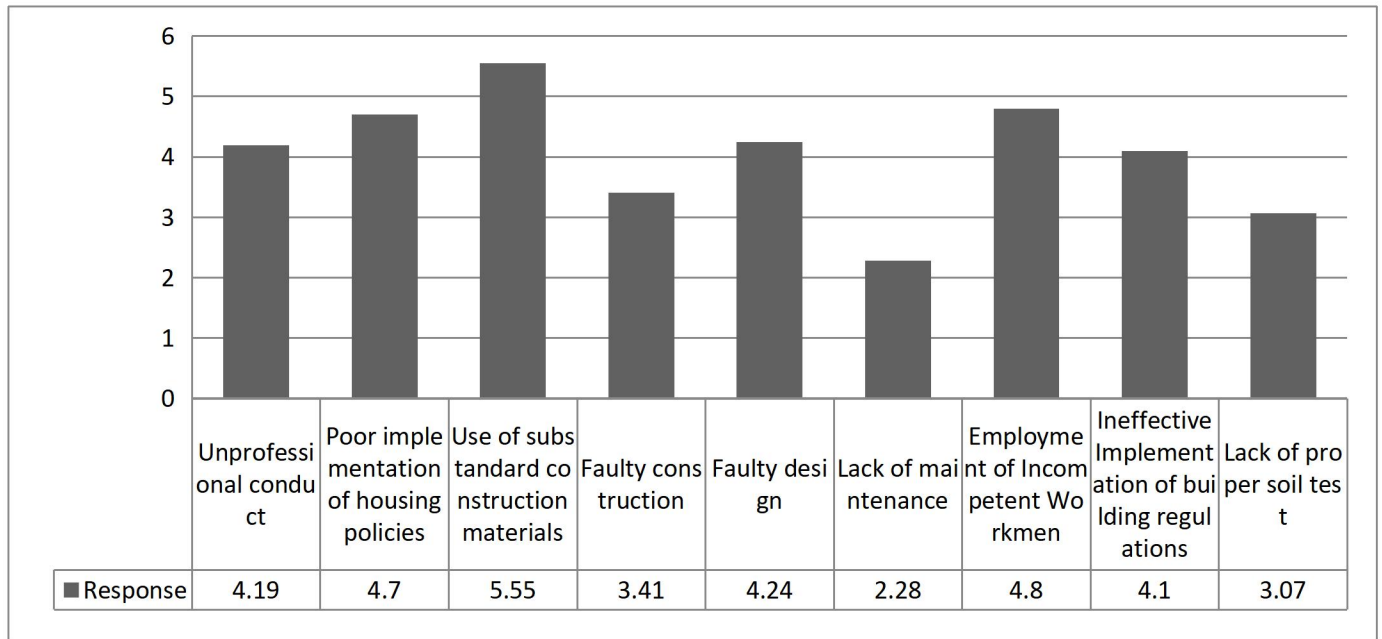
Figure 1: Questionnaire Responses on the Causes of Building Collapse in Edo State.

Fig. 1 shows the identified causes of building collapse in Edo State from the registered respondents. It shows that the identified causes such as; Employment of Incompetent workmen which was ranked 1st; Poor implementation of housing policies was ranked 2nd; Use of substandard construction materials was ranked 3rd; Unprofessional conduct was ranked 4th; Faulty construction was ranked 5th; Faulty design was ranked 6th; Lack of Maintenance was ranked 7th; Ineffective Implementation of building regulations was ranked 8th; Lack of proper soil test was ranked 9th.

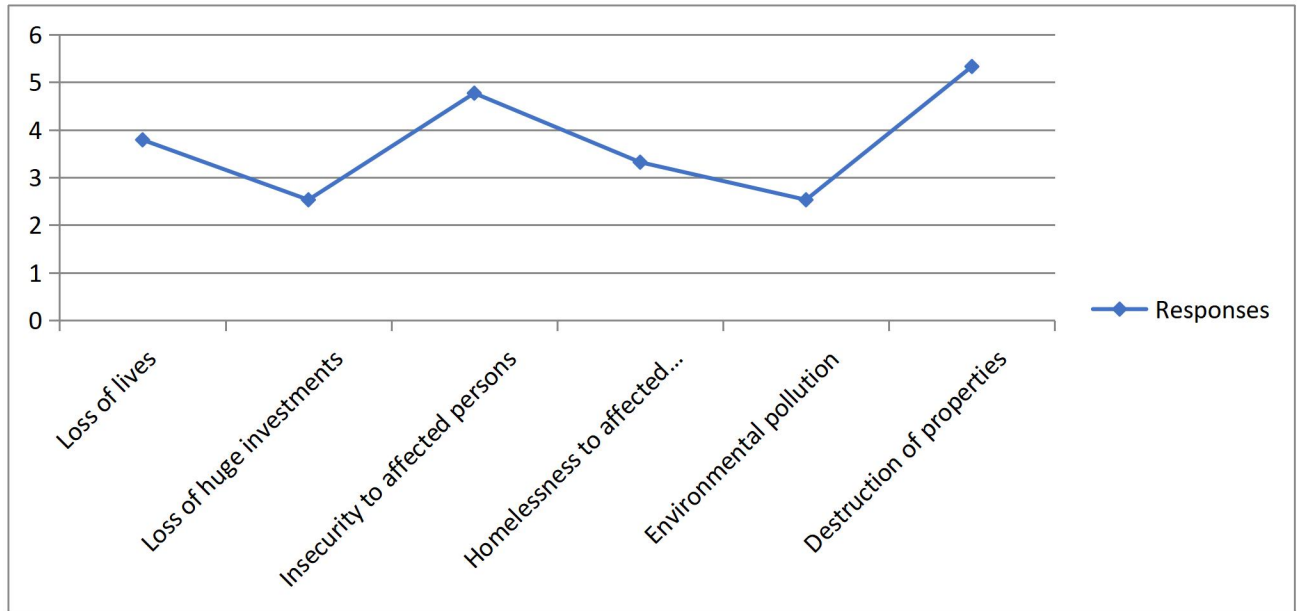
Figure 2: Questionnaire Responses on the Effects of Building Collapse in Edo State.

Fig. 2 reveals the identified effects of building collapse in Edo State. Destruction of properties was ranked 1st; Insecurity to affected persons was ranked 2nd; Homelessness to affected persons was ranked 4th; Loss of lives was ranked 3rd; Environmental pollution was ranked 5th; Loss of huge investments was ranked 6th.

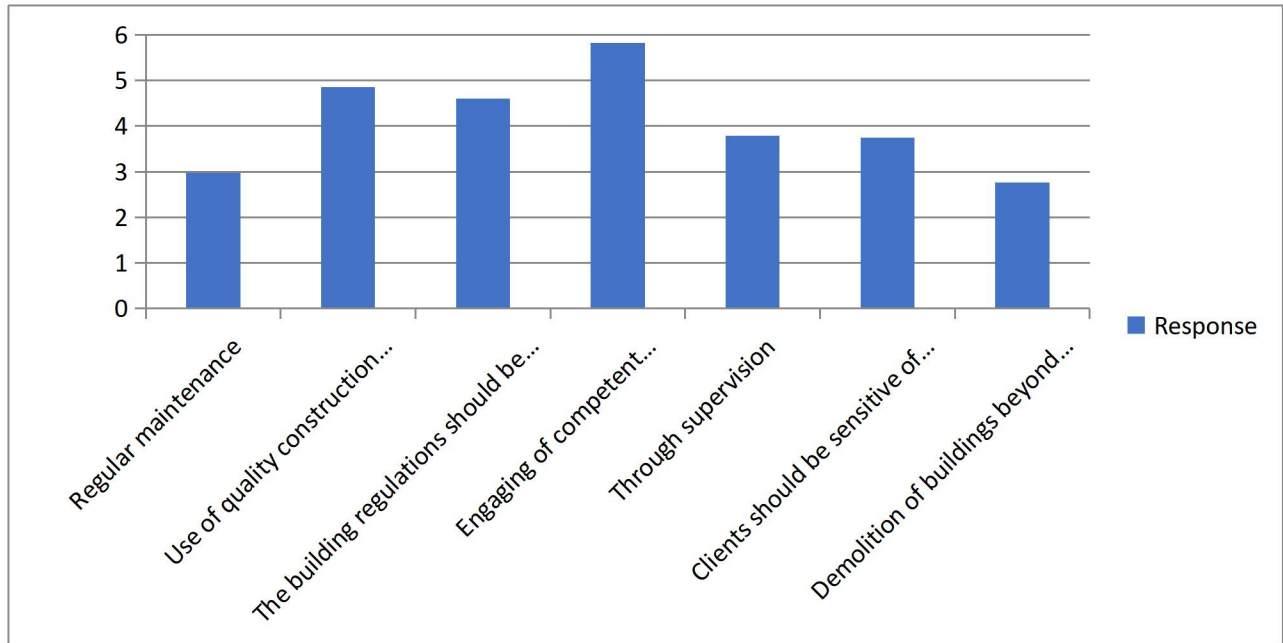
Figure 3: Questionnaire Responses on the Measures to Mitigate the Occurrence of Building Collapse in Edo State.

Fig. 3 shows the measures to mitigate the occurrence of building collapse in Edo State. Engaging of competent professionals ranked 1st. Use of quality construction materials ranked 2nd. The building regulations should be adhered to ranked 3rd. Clients should be sensitive of quality works ranked 4th. Through Supervision ranked 5th. Regular maintenance ranked 6th, and Demolition of buildings beyond repairs ranked 7th.

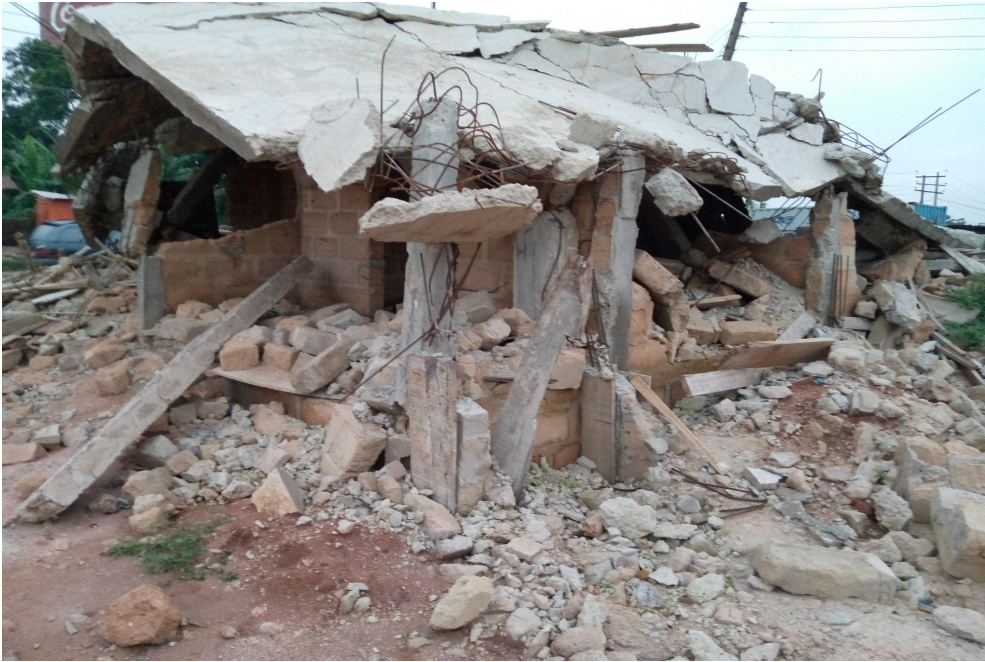
Plate A-3: Building after collapse

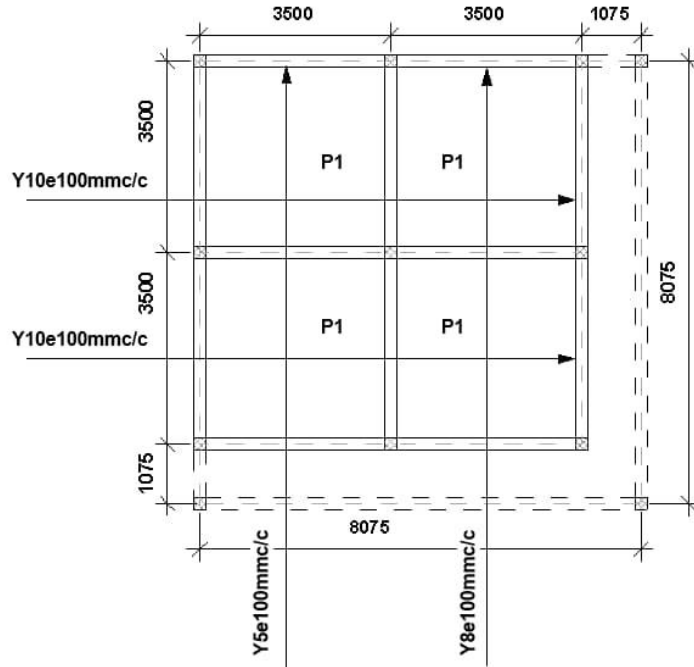
Figure A-5: Slab detailing

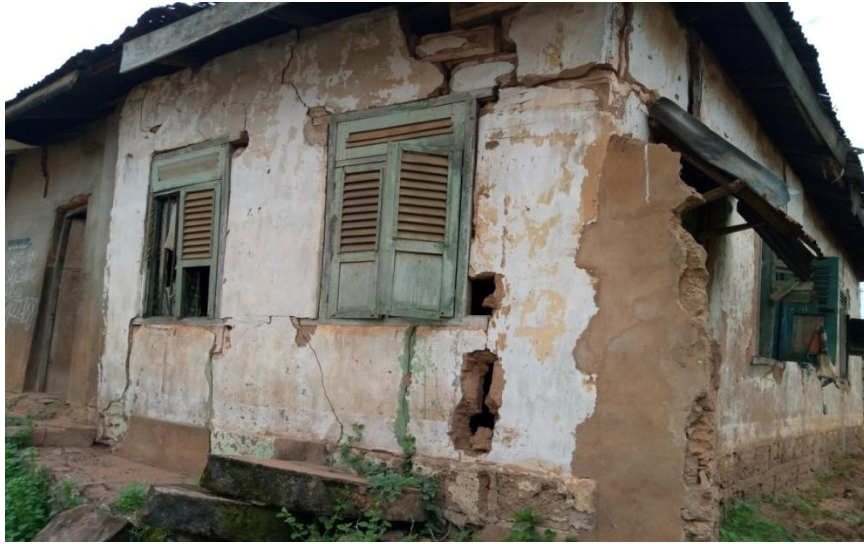
Plate B-3: Building after collapse

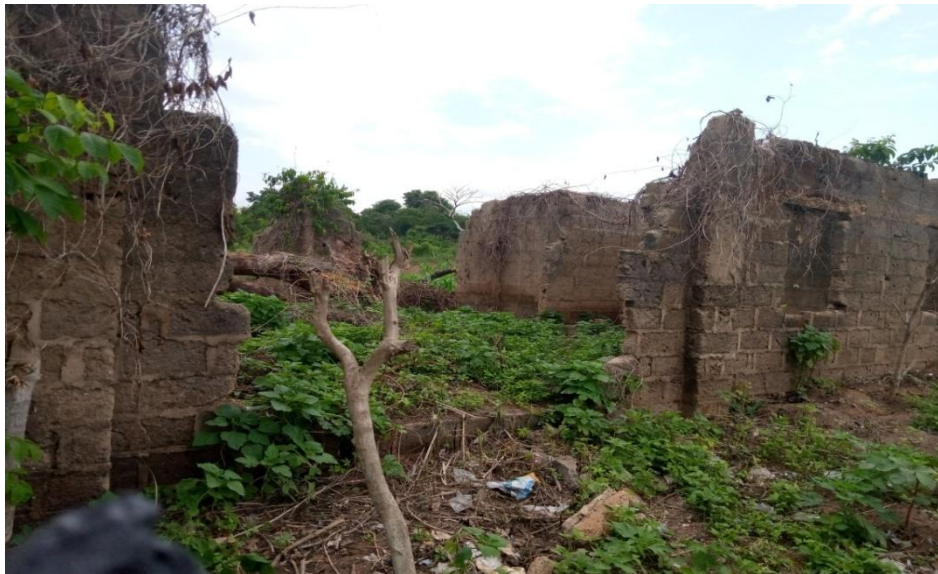
Plate C-3: Building after collapse

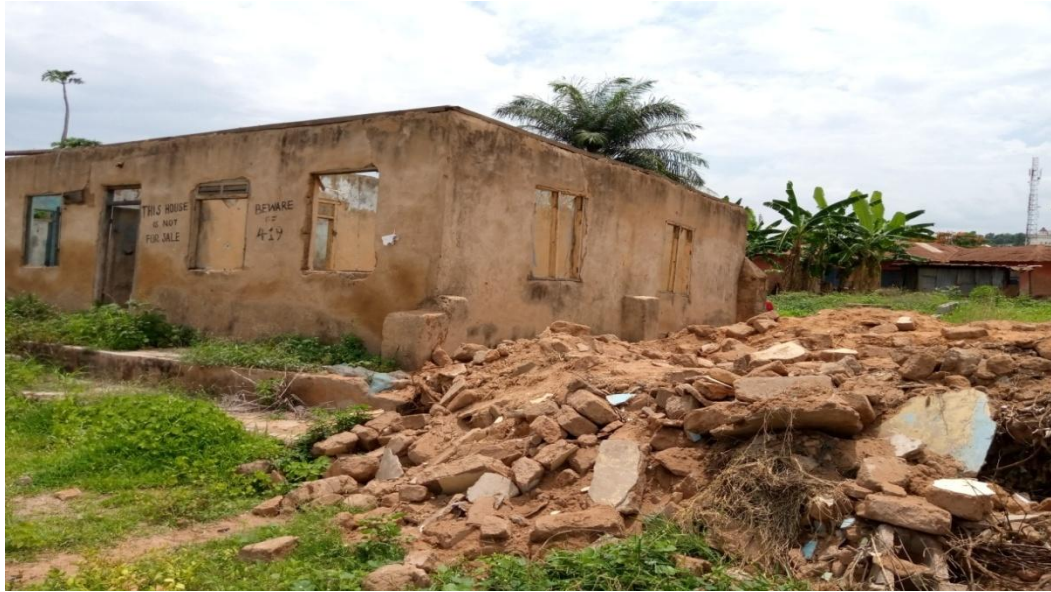
Plate D-3: Building after collapse

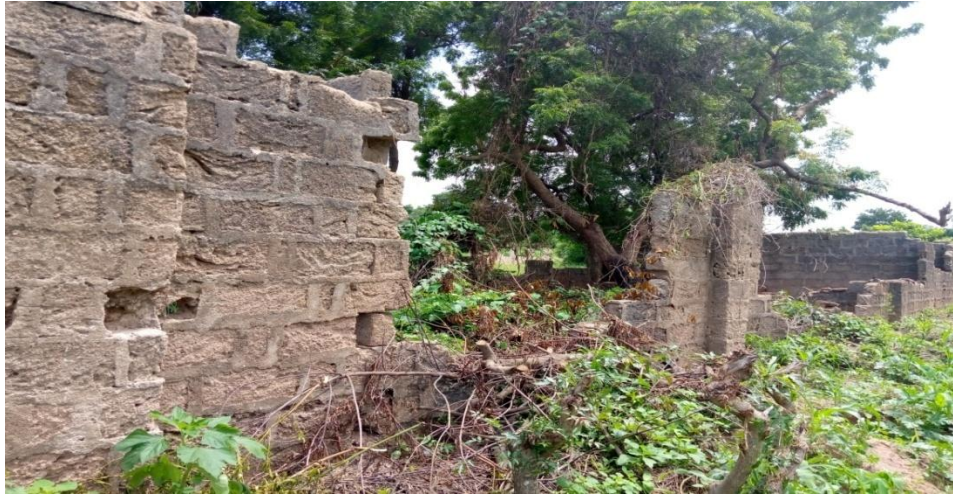
Plate E-3: Building after collapse
