EVALUATION ON THE CAUSES OF BUILDING COLLAPSE IN EDO STATE, NIGERIA

**A PROJECT WORK SUBMITTED IN PARTIAL FULFILLMENT OF THE
REQUIREMENTS FOR THE AWARD OF A BACHELOR OF ENGINEERING
(B. Eng.) DEGREE**

**THE DEPARTMENT OF CIVIL ENGINEERING,
FACULTY OF ENGINEERING,
UNIVERSITY OF BENIN (UNIBEN)
BENIN CITY, EDO STATE.**

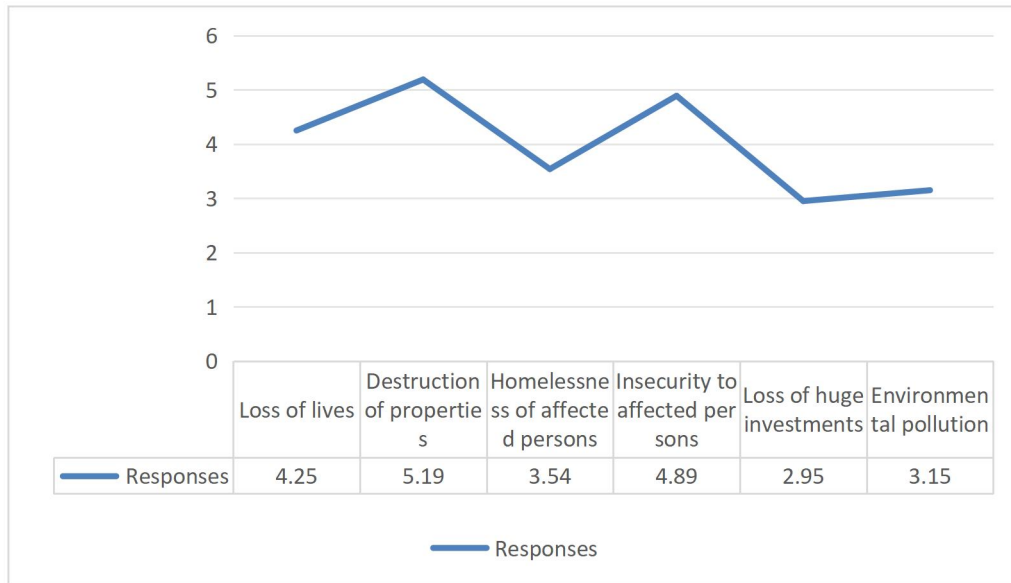
Figure 4.1: Questionnaire Responses on the Effects of Building Collapse in Edo State Nigeria

Fig 4.1 shows the identified effects of building collapse in Edo state. Destruction of properties was ranked 1st, insecurity to affected persons was ranked 2nd, loss of lives was ranked 3rd, homelessness of

affected persons was rank 4th, Environmental pollution was ranked 5th, lost of huge investments was ranked 6th.

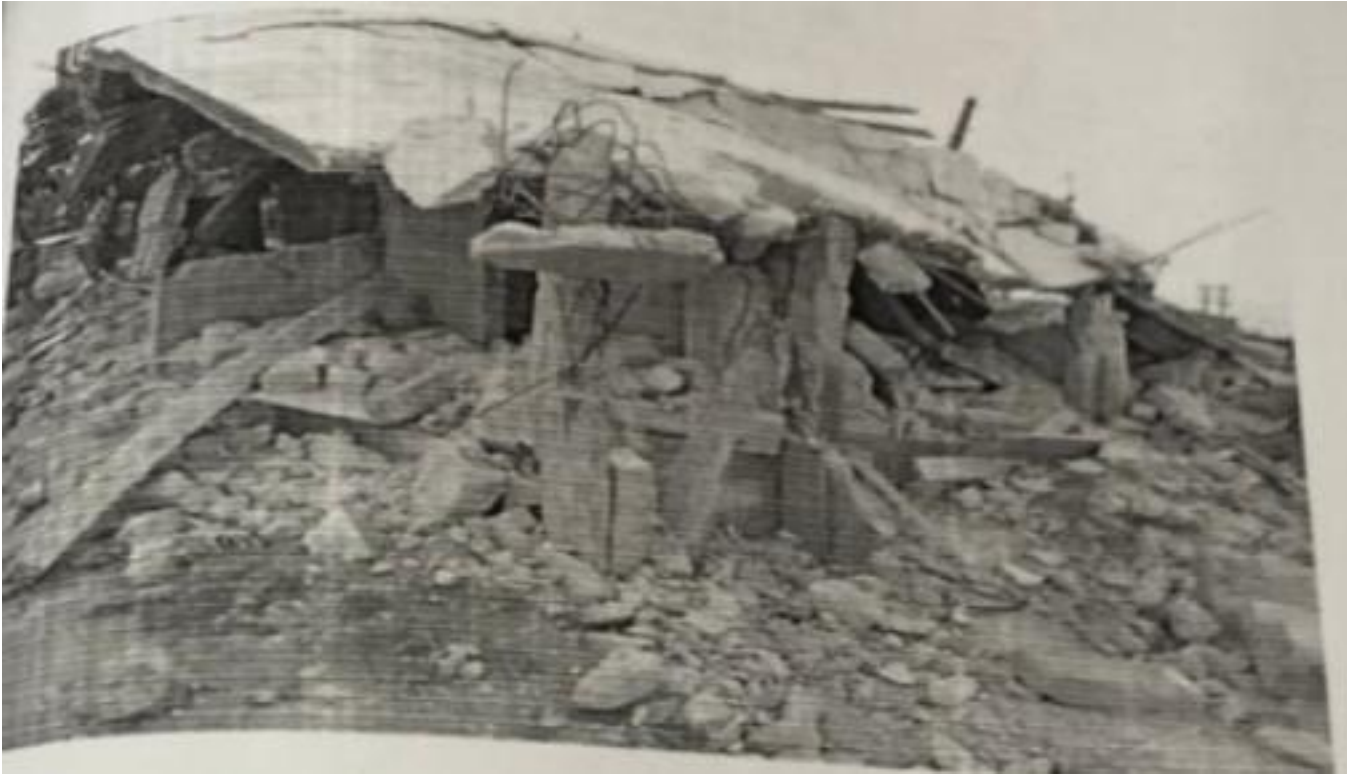
Plate A - 3: Building after collapse

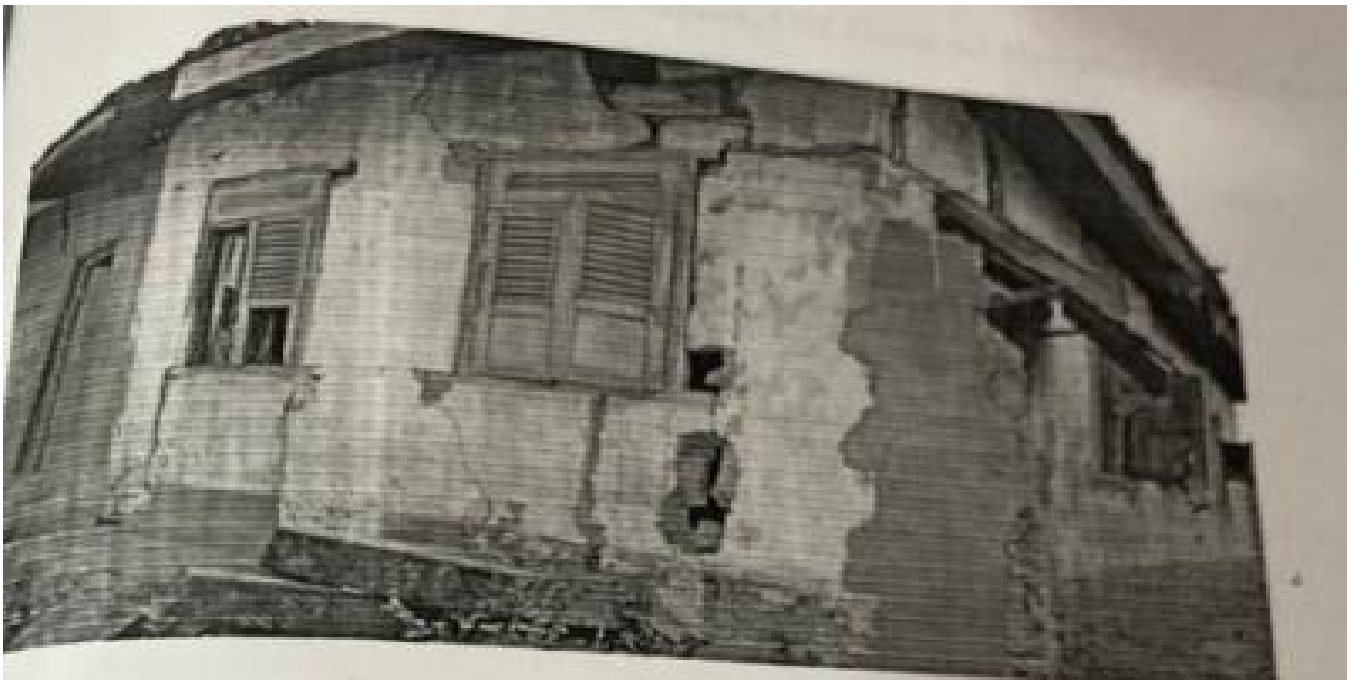
Plate B - 2: Building after collapse

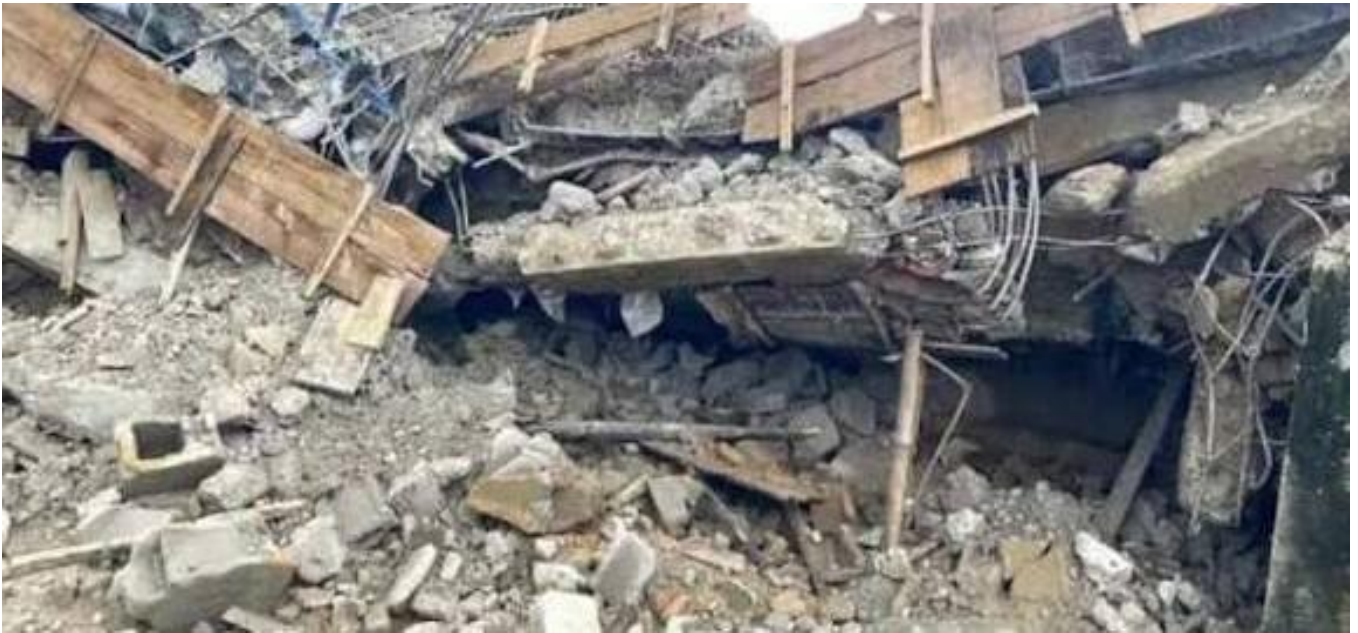
Plate C - 3: Building after Collapse

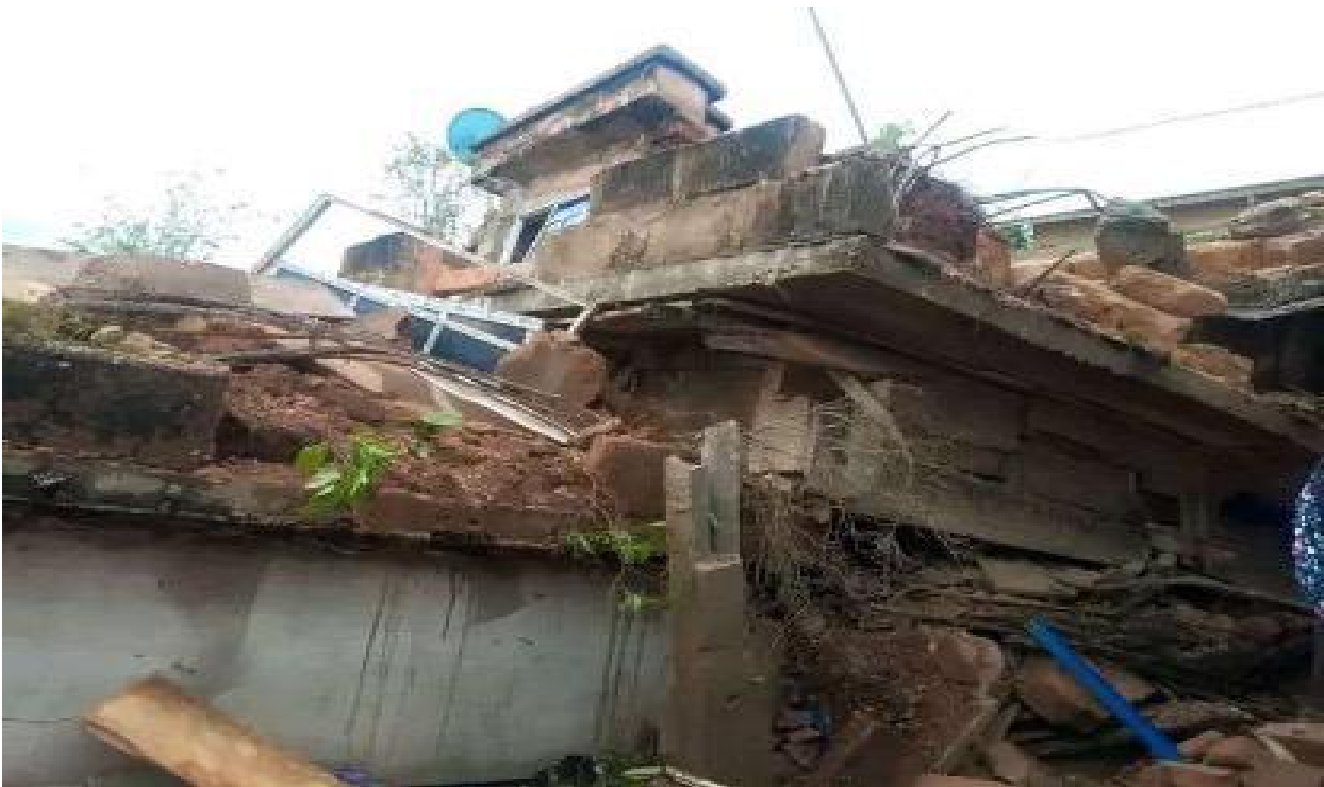
Plate D - 3: Building after collapse

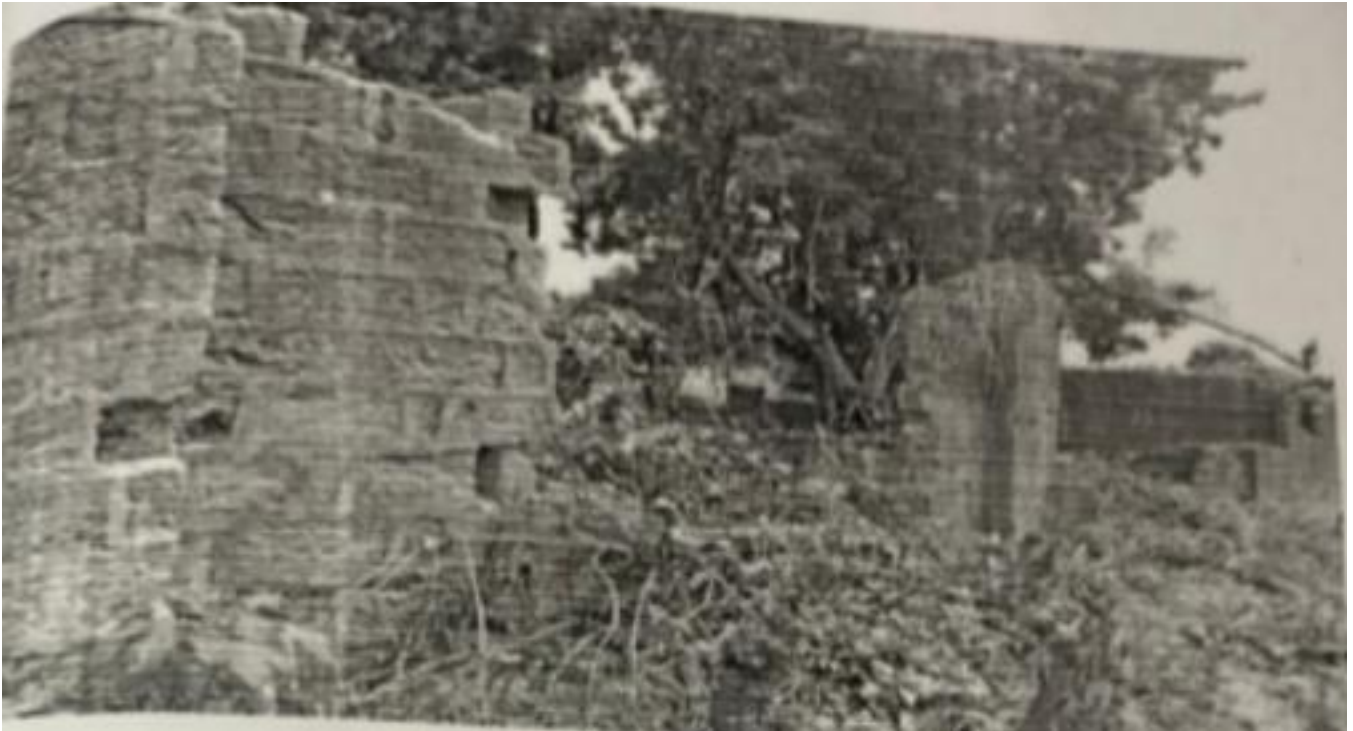
Plate E- 3: Building after collapse
