EVALUATING THE PERFORMANCE OF GABION RETAINING STRUCTURES IN
MITIGATING GULLY EROSION

OMORODION DESTINY

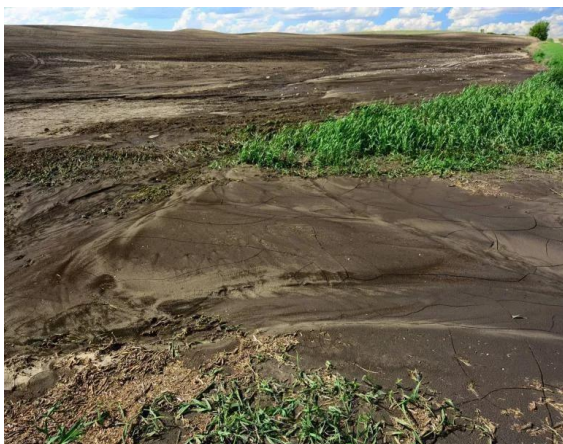
Plate 2.1: Sheet erosion on plowed native prairie in Stutsman County, North Dakota (*Rick Bohn/USFWS*)

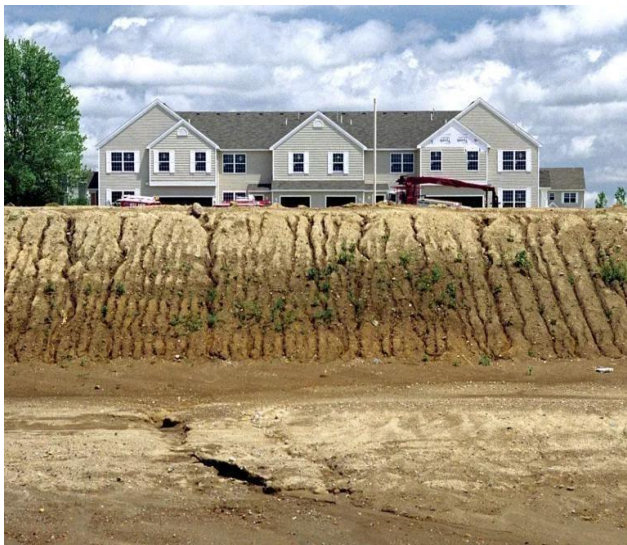
Plate 2.2: Rill erosion at a housing development site in Ankeny, Iowa (*Lynn Betts/USDA NRCS*)

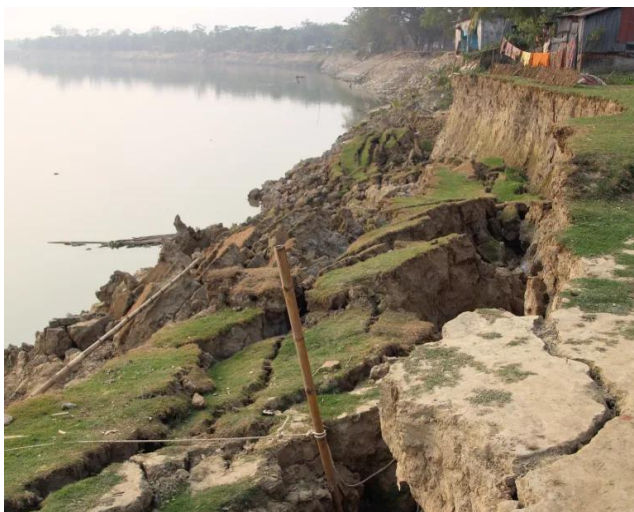
Plate 2.3: Bank erosion in Sunamganj, Bangladesh | Malcolm Dickson/Water Alternatives, CC-BY-NC 4.0

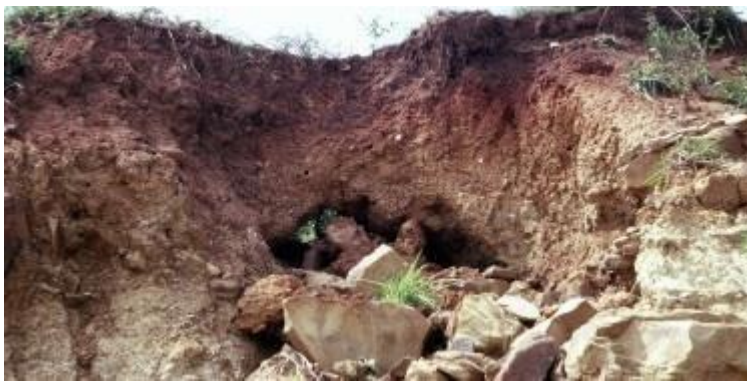
Plate 2.4: *Tunnel erosion in Marburg, Queensland (Wikipedia)*

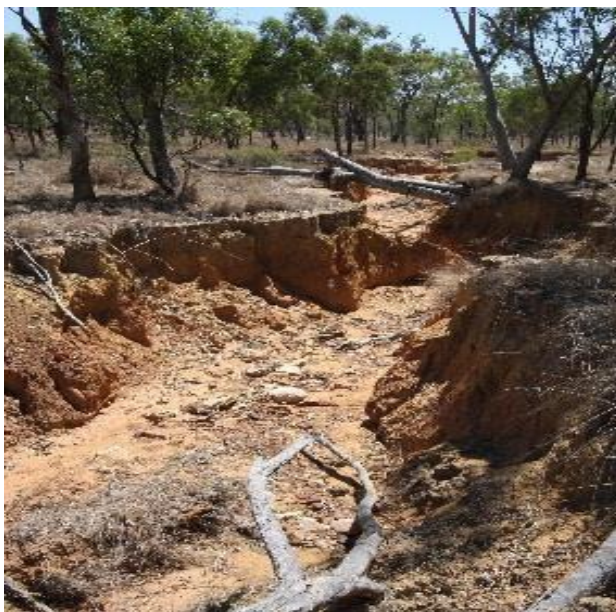
Plate 2.5: A highly eroded gully

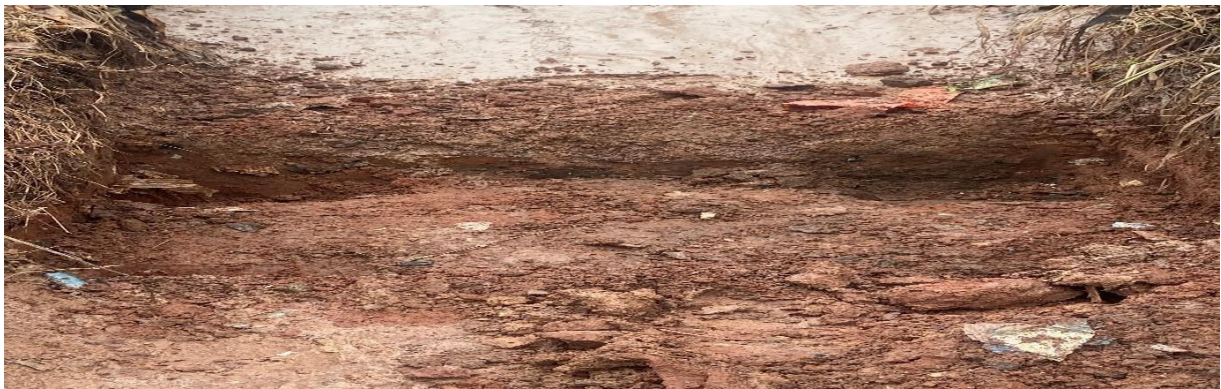
Plate 3.4: Foundation Preparation
