**STRUCTURAL INTEGRITY ASSESSMENT OF EXISTING DRAINAGE  
INFRASTRUCTURE ALONG UGBOWO BENIN CITY, EDO STATE. NIGERIA.**

**A PROJECT SUBMITTED IN PARTIAL FULFILLMENT OF THE REQUIREMENTS  
FOR THE AWARD OF BACHELOR OF ENGINEERING (B.Eng) DEGREE.**

**THE DEPARTMENT OF STRUCTURAL ENGINEERING**

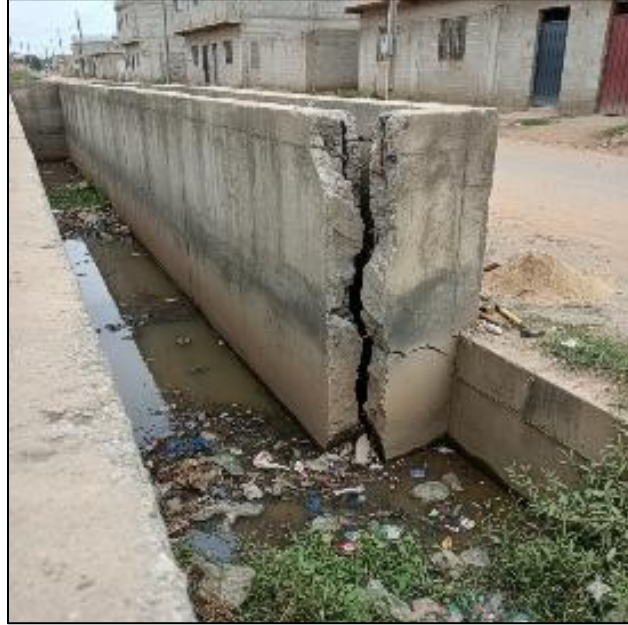
**Figure 2.1:** Common structural failure (cracking in a rectangular concrete drainage channel).

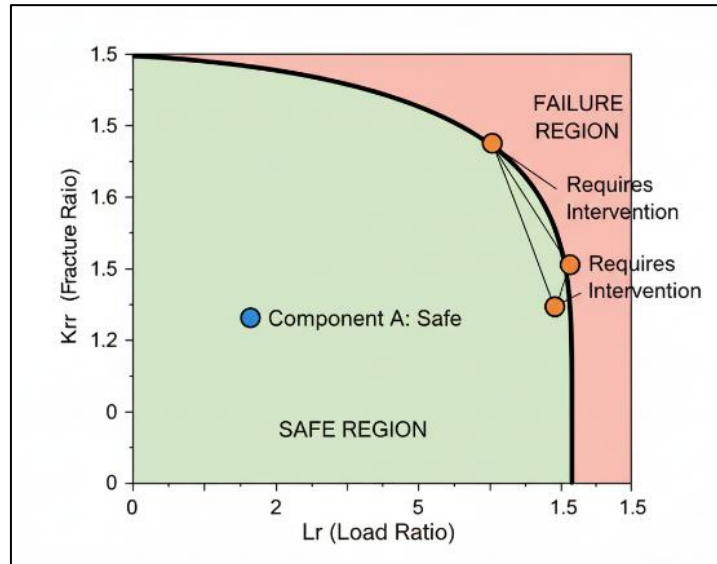
Figure 2.2: Schematic representation of failure assessment diagram showing the safe assessment region and the failure assessment line. (Source adapted from Kikuchi, 2007).

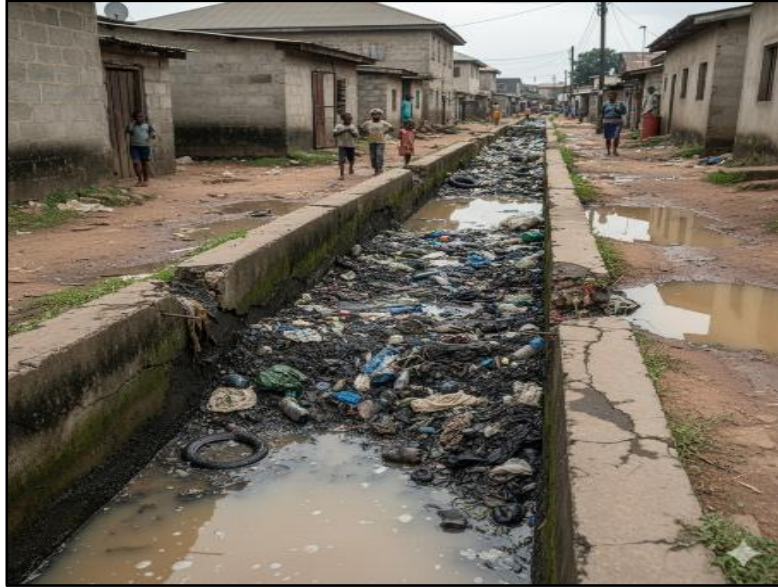
**Figure 2.5:** Example of severe sediment and debris accumulation compromising the flow capacity of an urban drainage channel.

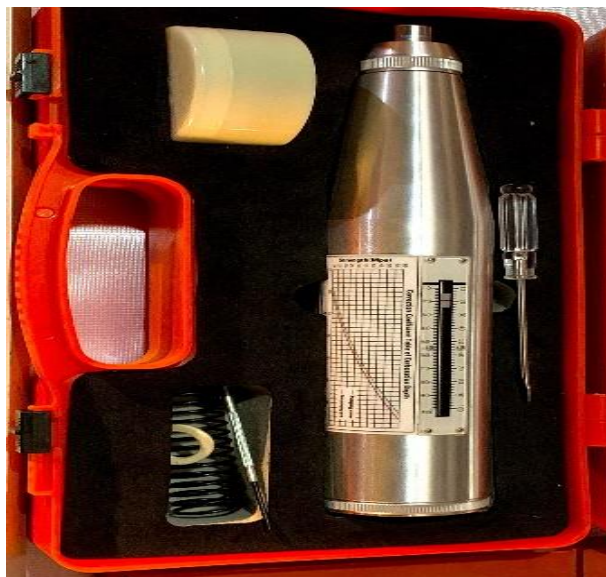
**Figure 3.4:** Schmidt rebound hammer used for surface hardness testing.

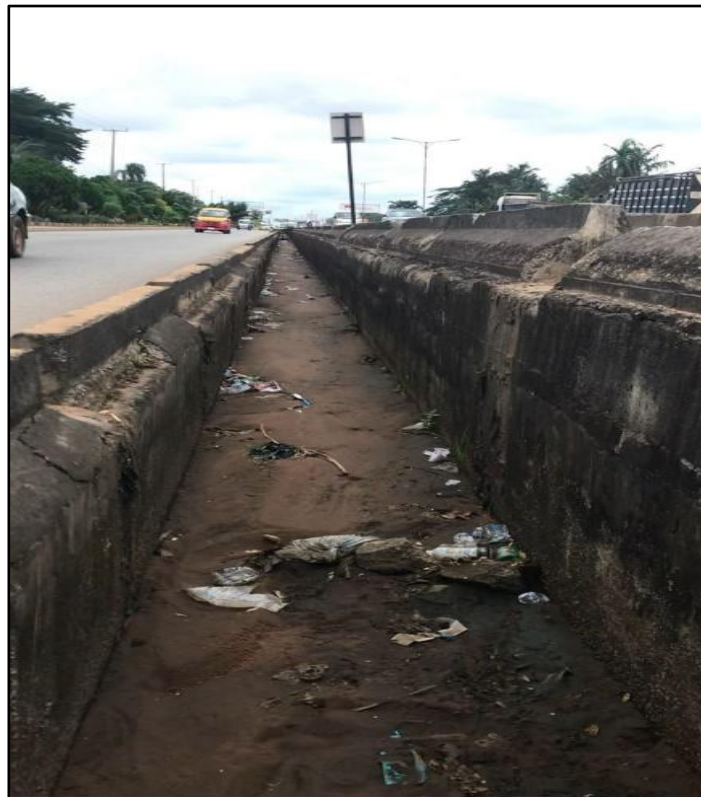
**Figure 4.1:** Severe sedimentation and debris (Hydraulic failure).

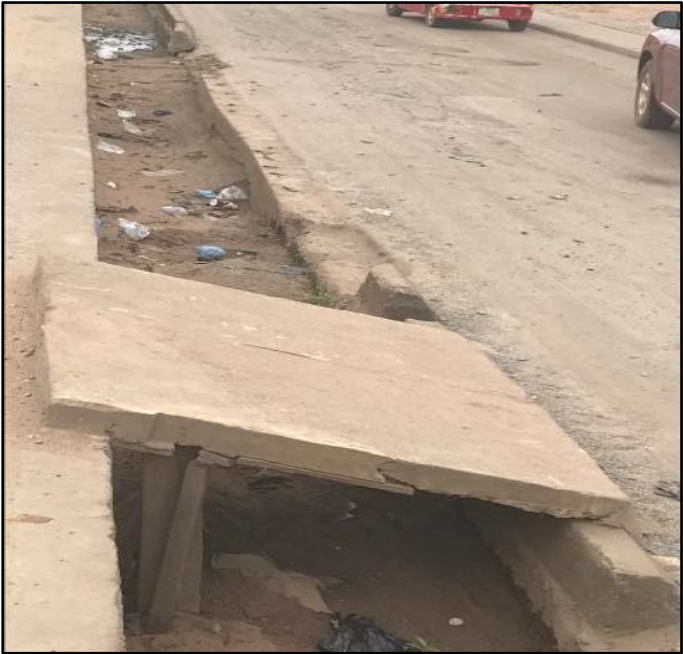
**Figure 4.2:** Structural failure characterized by a displaced concrete cover, indicating differential settlement and a critical safety hazard along the drainage alignment.

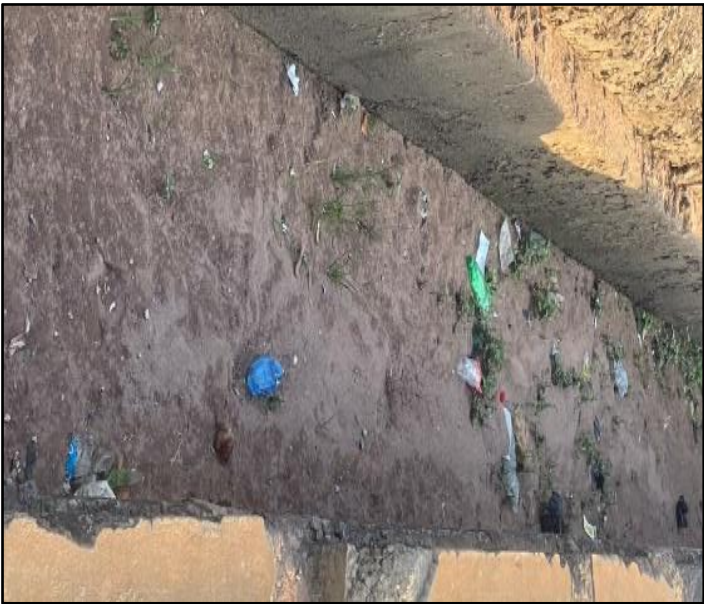
**Figure 4.3:** Biological growth within the drainage channel, facilitated by heavy sediment deposition, accelerating wall deterioration and increasing flow resistance.

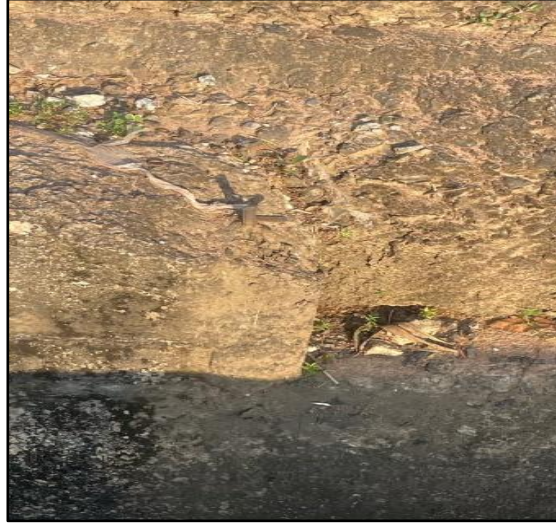
**Figure 4.4:** Material degradation/ Spalling.

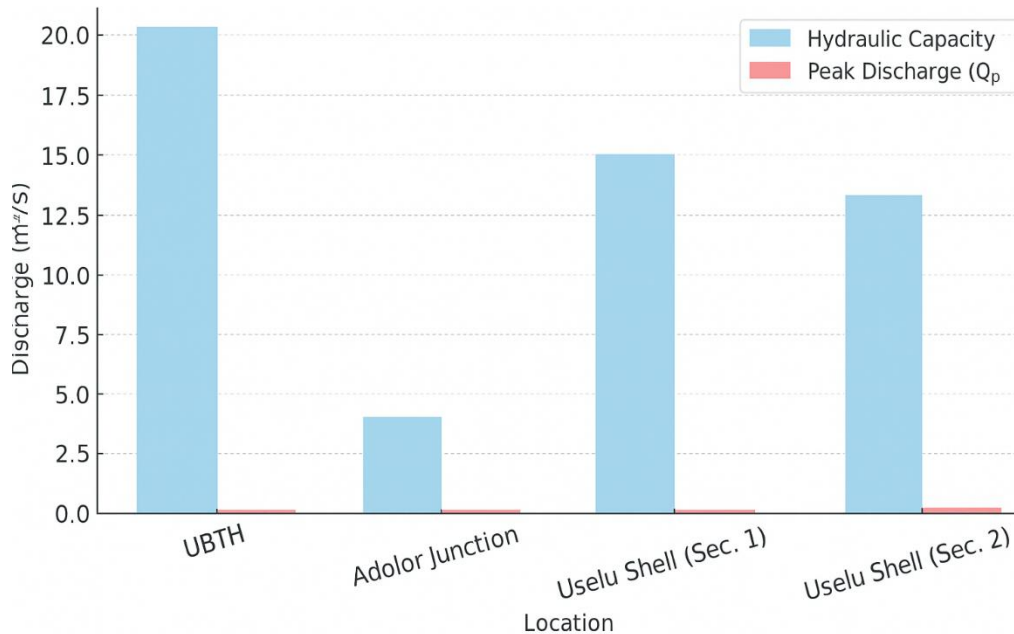
- a) **Identification of insufficient channel:** All drainage sections have computed capacities ( $Q$ ) above their peak discharges ( $Q_p$ ) for a 50 mm/hr storm, showing adequate conveyance: UBTH (20.44 m<sup>3</sup>/s), Adolor Junction (3.21 m<sup>3</sup>/s), Uselu Shell 1 (14.88 m<sup>3</sup>/s), and Uselu Shell 2 (13.29 m<sup>3</sup>/s). Efficiency may be reduced by sediment, debris, or low slopes. Adolor Junction, with its shallow rectangular section, is most prone to flooding.

**Figure 4.10:** Comparison of Hydraulic Capacity and Peak Discharge across Locations.

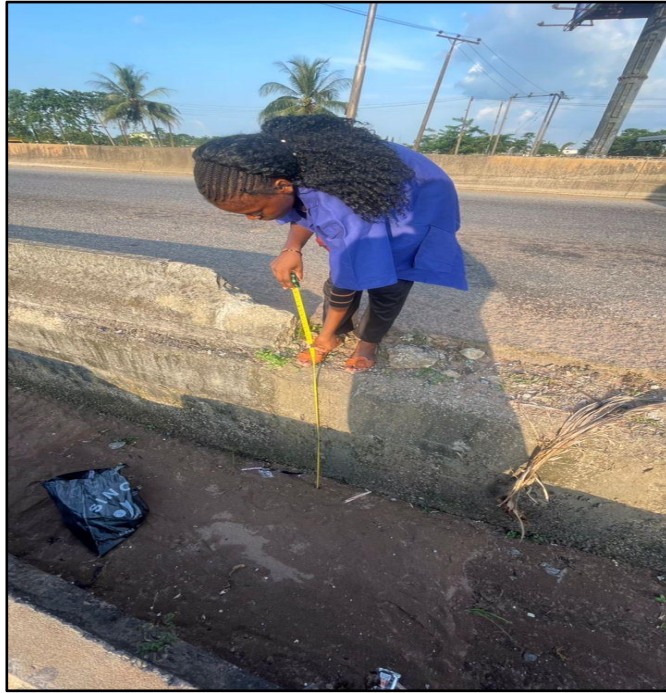
**Plate A1:** Field measurement of channel depth and siltation.

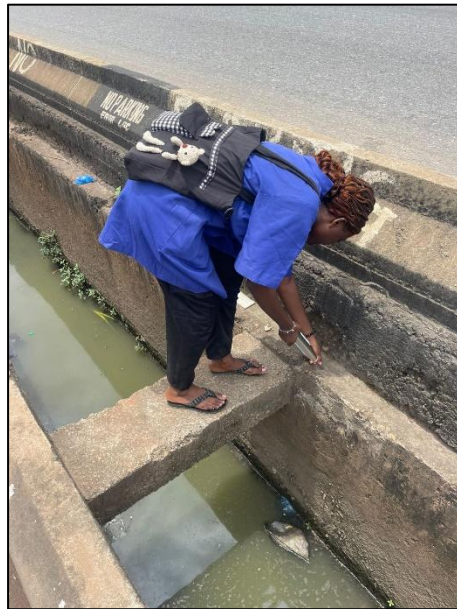
**Plate A2:** Non-destructive testing (visual documentation).
