**USE OF MACHINE LEARNING FOR DEFECT DETECTION IN
FLEXIBLE PAVEMENT**

**A PROJECT SUBMITTED IN PARTIAL FULFILLMENT OF THE REQUIREMENT
FOR THE AWARD OF BACHELOR OF ENGINEERING**

**THE DEPARTMENT OF CIVIL ENGINEERING,
FACULTY OF ENGINEERING,
UNIVERSITY OF BENIN, BENIN CITY, NIGERIA.**

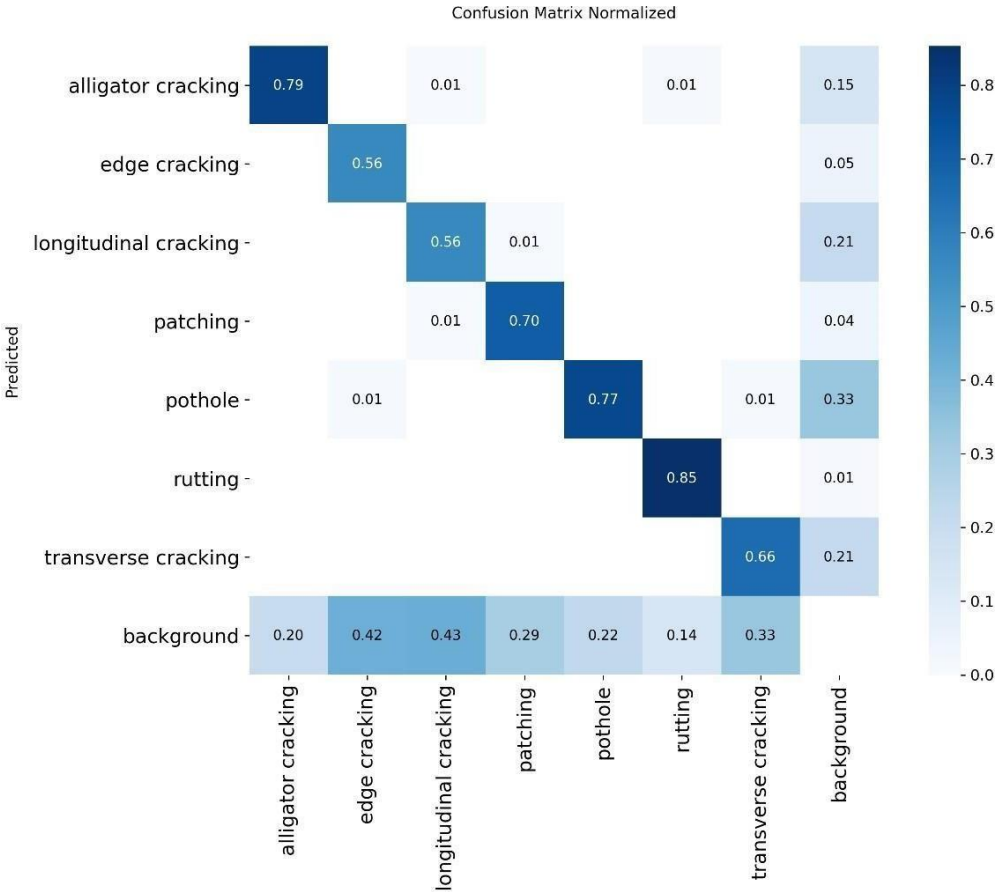
Fig 4.13: Normalized confusion matrix for Case 2

In the second training phase, the model showed improved ability in correctly identifying certain pavement defects. It performed very well in detecting rutting (0.85), potholes (0.77), and alligator cracking (0.79). These high scores mean the model could easily tell these defects apart from others because they have clear and unique features like depth, rough texture, or irregular surface patterns that stand out in road images.

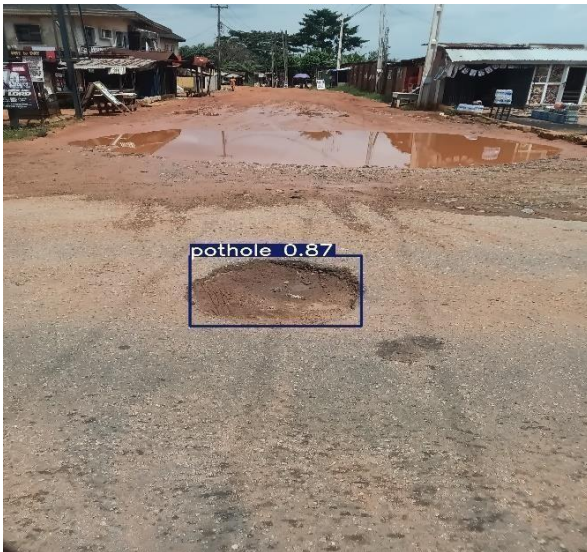
Fig 4.17: Pothole detected with a precision Level of 87%

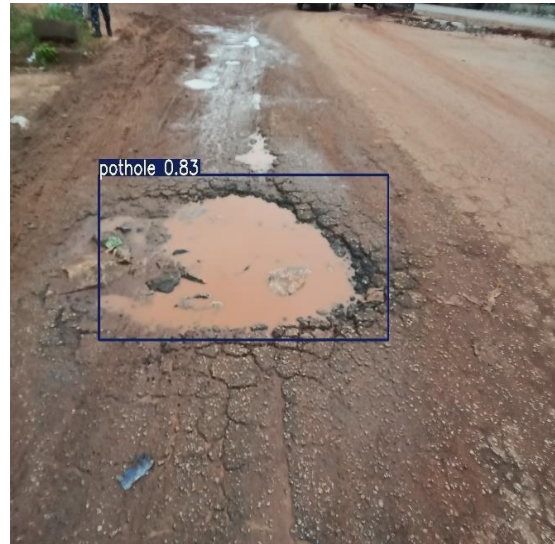
Fig 4.18: Pothole detected with a precision of 83%

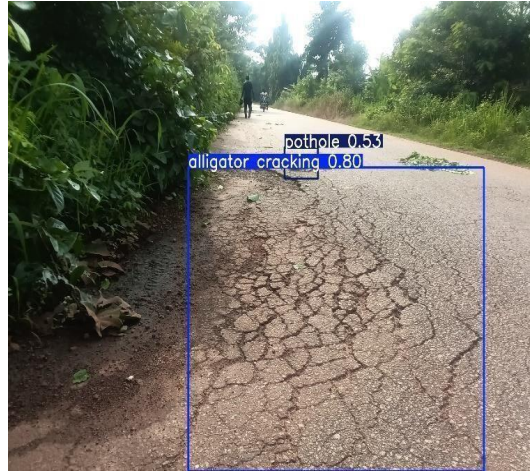
Fig 4.19: Alligator Crack detected with 80%

Precision value
