EVALUATION OF POLYETHYLENE TAPE COATING/MILD STEEL BOND FAILURE ON
THE SOIL-TO-AIR REGION OF A CRUDE OIL PIPELINE

A PROJECT PRESENTED TO THE
DEPARTMENT OF MECHANICAL ENGINEERING,
FACULTY OF ENGINEERING,
UNIVERSITY OF BENIN, BENIN CITY, EDO STATE, NIGERIA

IN PARTIAL FULFILMENT OF THE REQUIREMENT FOR THE AWARD OF MASTER OF
ENGINEERING (IN INDUSTRIAL METALLURGY AND CORROSION MANAGEMENT)

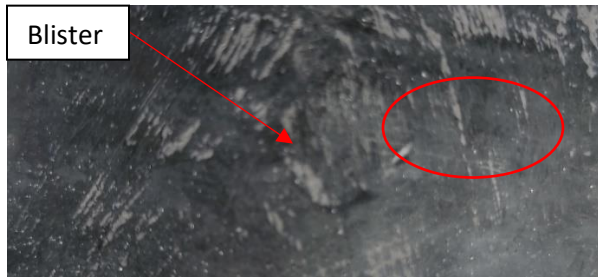
Specimen 4a (Above ground) External Tape coating surface

The visual examination of the results in fig 4.1 to 4.4 shows that there was degradation on the tape coating surface and rusting on the pipeline metal surface, both for above ground and below ground. The tape coating degradation seems to increase from specimen 1 to specimen 4. This can be attributed to specimen 1 been farthest from human activities while specimen 4 is the closest. Human activities around the tape coating could have affected the ability of the polyethylene tape coating to function as effectively, however, specimen 1 to 3 still shows a good resistance against mechanical coating damage which is in agreement with Yoshiyuki et al,1990, whose survey indicated that polyethylene coating has good resistance against mechanical coating damage but differ in terms of corrosion protection where Yoshiyuki et al,1990 noted that polyethylene coating provided good corrosion protection over the 14years period covered by their survey, specimen 1 to 4 did not provide the same protection after 14years. This can be attributed to the form in which the polyethylene coating is applied, one as an organic coating (paint) while the other as an organic coating (Tape).

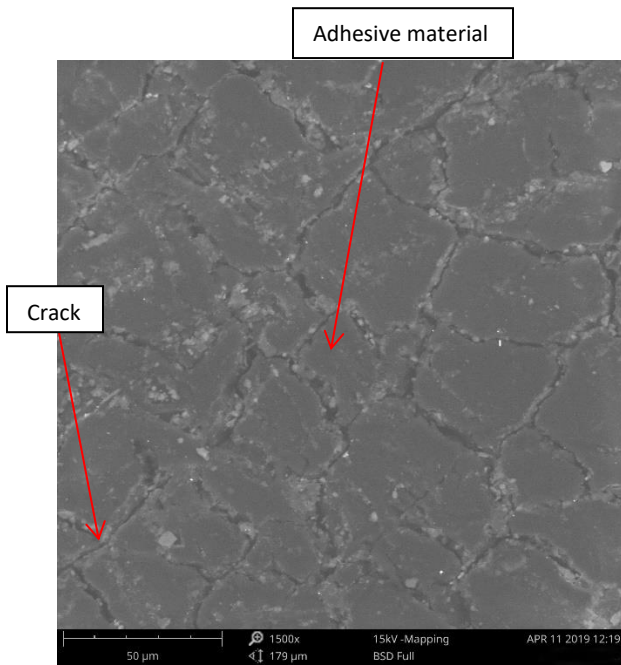
Tape specimen 1b shows no significant evidence of corrosion product on surface of tape/pipe interface, mere general corrosion. Weblike cracks on the tape surface indicates more general adhesive degradation resulting in shrinkage, embrittlement due to long exposure to the elements as compared to tape specimen 1a.

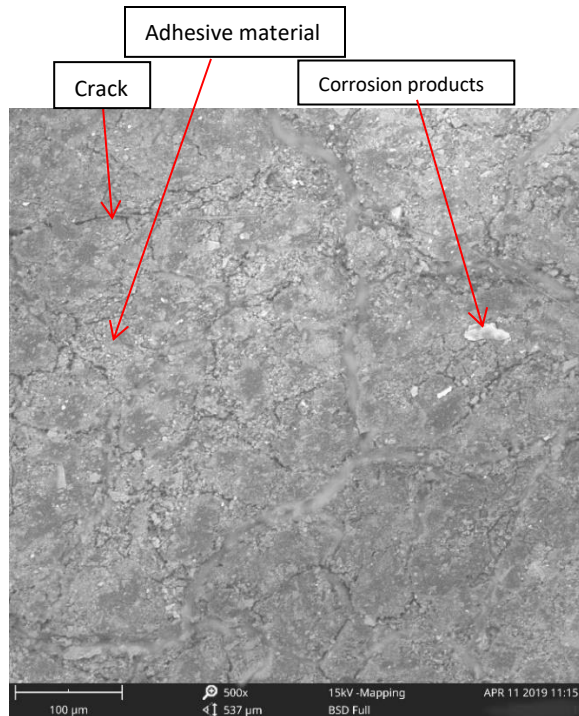
Figure 4.7 Presents image of SEM of the Tape coating taken above ground from Pipeline 2:

Tape specimen 2a shows more evidence of corrosion products on surface of tape/pipe interface. Weblike cracks on the tape surface also indicates general adhesive degradation resulting in shrinkage, embrittlement due to long exposure to the elements.

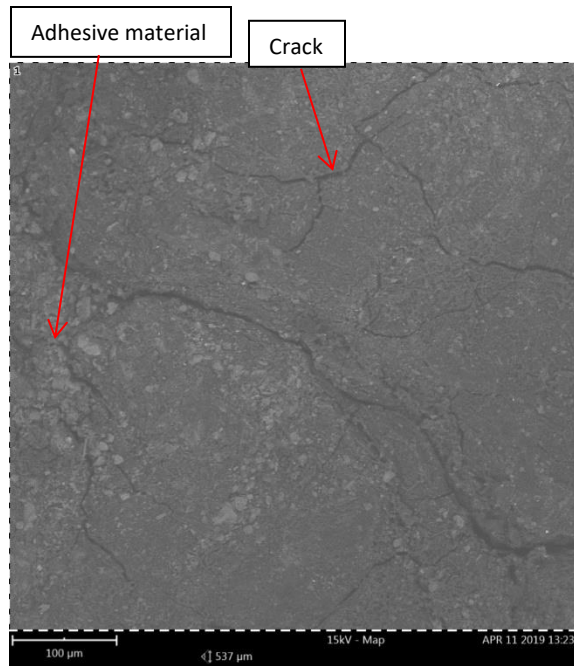
Figure 4.8 Presents image of SEM of the Tape coating taken below ground from Pipeline 2:

Tape specimen 2b shows more evidence of corrosion products on surface of tape/pipe interface compared to specimen 2a. Weblike cracks on the tape surface also indicates general adhesive degradation resulting in shrinkage, embrittlement due to long exposure to the elements. A significant layer of adhesive material also noted on the tape coating surface.

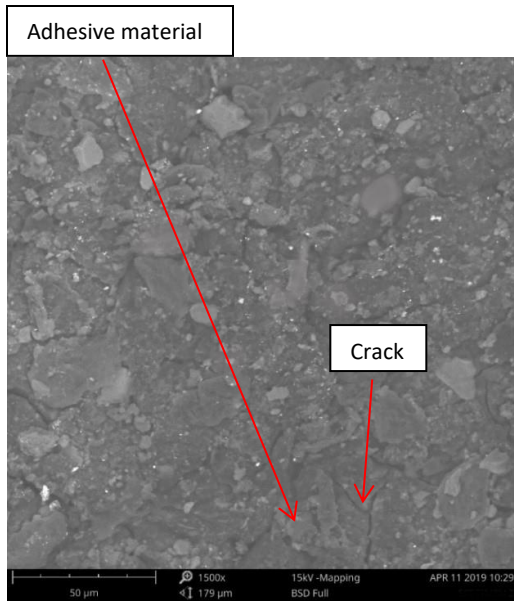
Figure 4.10 Presents image of SEM of the Tape coating taken below ground from Pipeline 3:

Tape specimen 3b shows more evidence of corrosion products on surface of tape/pipe interface as compared to specimen 3b. Weblike cracks on the surface indicates general adhesive degradation resulting in shrinkage, embrittlement due to long exposure to the elements. A significant layer of adhesive material also noted on the tape coating surface.

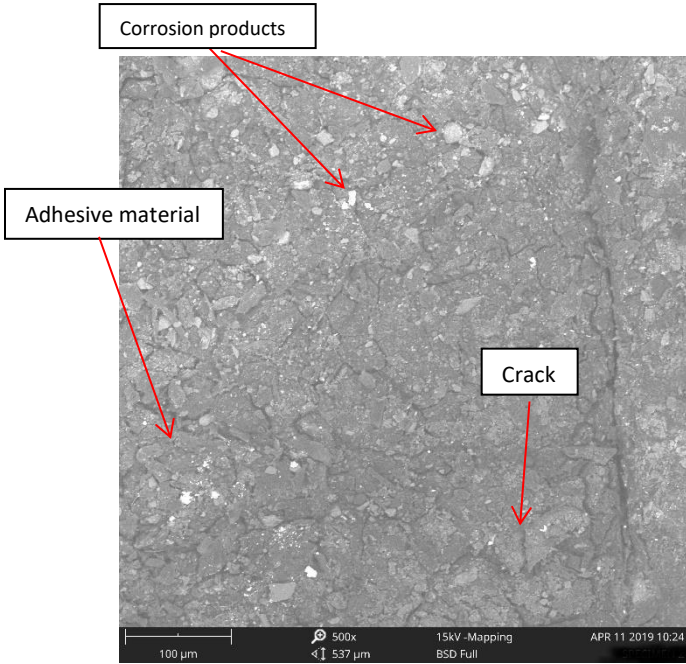
Figure 4.11 Presents image of SEM of the Tape coating taken above ground from Pipeline 4:

Tape specimen 4a shows spread of corrosion products on surface of tape/pipe interface. Weblike cracks on the surface indicates general adhesive degradation resulting in shrinkage, embrittlement due to long exposure to the elements. A significant layer of adhesive material also noted on the tape coating surface.

The presence of metallics particles on the micrograph, more visible on specimen 4a & b agree with the visual evidence of undercoating corrosion on the metal surface.

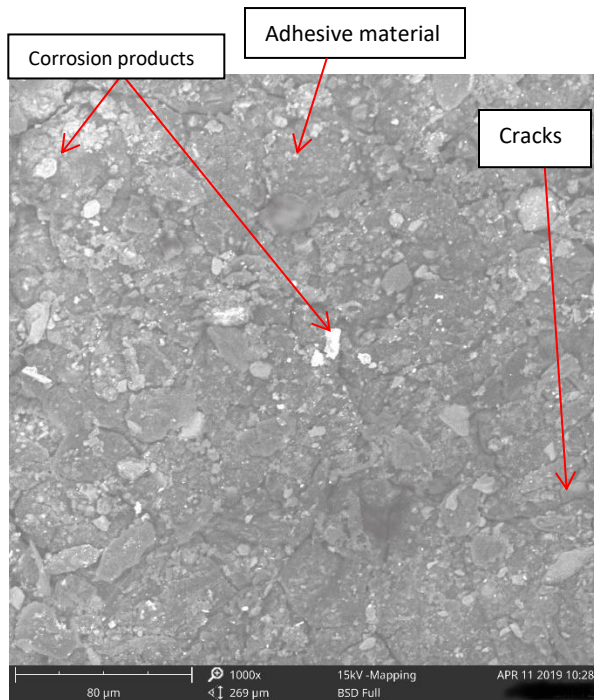
Figure 4.12 Presents image of SEM of the Tape coating taken below ground from Pipeline 4:

Tape specimen 4b shows more spread of corrosion products on the surface of tape/pipe interface and evidence of scaling. Weblike cracks on the surface indicates general adhesive degradation resulting in shrinkage, embrittlement due to long exposure to the elements. A significant layer of adhesive material also noted on the tape coating surface.

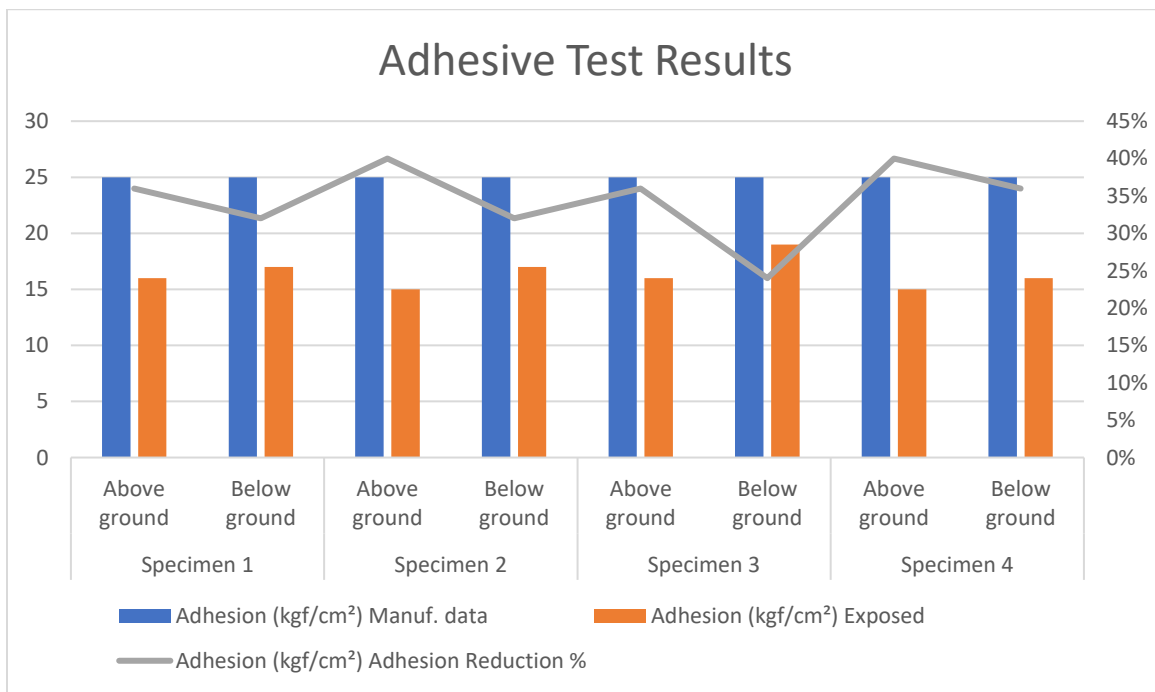
Figure 4.13. Showing graphical representation of Adhesive test result.

The results obtained here shows that the bond between the metal surface and adhesive/tape are good but prolong exposure to the field environment resulted in the deterioration at the metal surface/adhesive interface for both above and below ground.

The result from the graph shows reduction in adhesive strength ranging from 24% to 40%.

The results obtained here implies that the bonding between the coating and dolly was more than the substrate and the metal surface hence the failures were coagulative in nature between the metal surface and adhesive layer for above and below ground. There is evidence of reduced adhesive strength when compared to manufacturer's adhesive strength values. This is shown in Figure 4.13. Figure 4.5 to 4.12 shows adhesive layers that have hardened, became brittle (visible weblike cracks from images) and lost its ductility to resist impact/movement from service conditions. The butyl rubber adhesives used as bonding layer, the metal surface corrode, and such corrosion process may compromise the performance of the adhesive surface, either at the bonded interface or adjacent to it. There are three distinct failure processes could occur on the adhesive joint durability; interfacial failure due to water hydrolysis of the adhesive from the substrate, the degradation of the adhesive itself in the service environments, and the interfacial failure as a result of cathodic or anodic activity at the substrate, referred to as either cathodic delamination or anodic undermining (Watts, 2010). This is in agreement with Ismaliza et al, 2013, whose experiment on Evaluation of Rubber/Mild Steel Bonds Failure after Exposure in Marine Environment, where the failure was at the primer/metal interface also exhibited similar results even though the test environment was different.

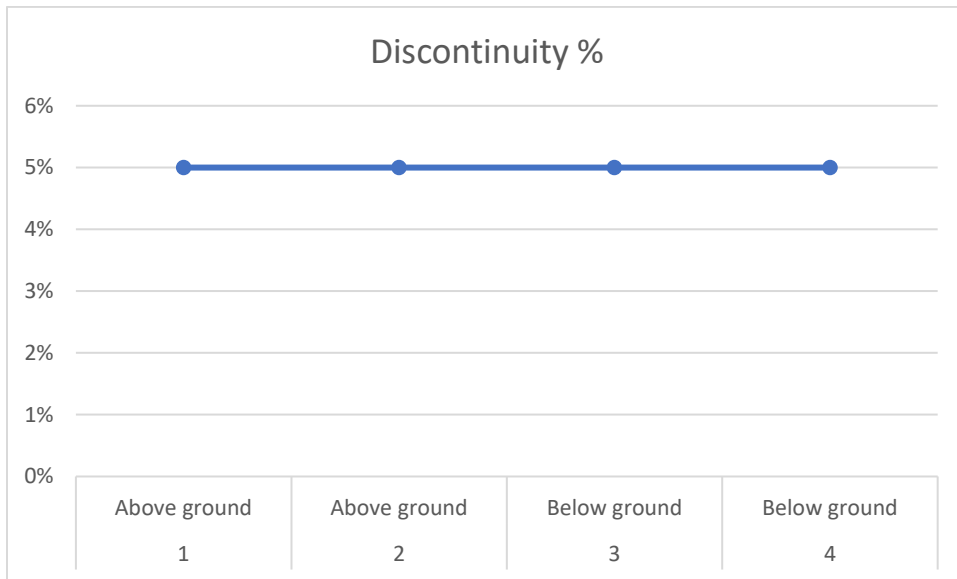
Figure 4.14 Shows graphical presentation of percentage discontinuity from scan on specimen 1 from Pipeline 1.

Results from the holiday test assessing the areas of Tape coating discontinuity (Disbondment) are shown in Figure 4.14 to 4.17. The profile of the polyethylene tape is measured 6 inches length in the axial direction per section under assessment, from above grade toward below grade. Discontinuity in the surface adhesion (Holiday) was noted on all the specimens between the Polyethylene tape coating and the pipeline external. This is like the failure observed by Alrudayni, 2015. The transformation of the adhesive layer from a soft and high adhesive strength material with high surface energy to a hard and brittle material (as evident on the SEM image) also contributed to the disbondment as the tape resistance to mechanical and thermal stresses are reduced. Trapped air within the system during installation could not be ruled out as the cause of the micro void space (holiday) underneath the polyethylene tape coating. The process of cold installing of the tape does not normally include holiday tests after installation hence no valid record to show the absence of holiday.
