**FAILURE INVESTIGATION AND PERFORMANCE ANALYSIS OF THE  
COMBUSTION AND EMISSION CHARACTERISTICS OF AN INDUSTRIAL DUAL  
FIRED STEAM BOILER**

**MARCH 2026**

**A THESIS SUBMITTED TO THE DEPARTMENT OF MECHANICAL  
ENGINEERING, FACULTY OF ENGINEERING IN PARTIAL FULFILMENT OF  
THE REQUIREMENTS FOR THE AWARD OF A DOCTOR OF PHILOSOPHY  
(Ph.D) DEGREE IN MECHANICAL ENGINEERING (THERMAL POWER  
ENGINEERING) AT THE UNIVERSITY OF BENIN**

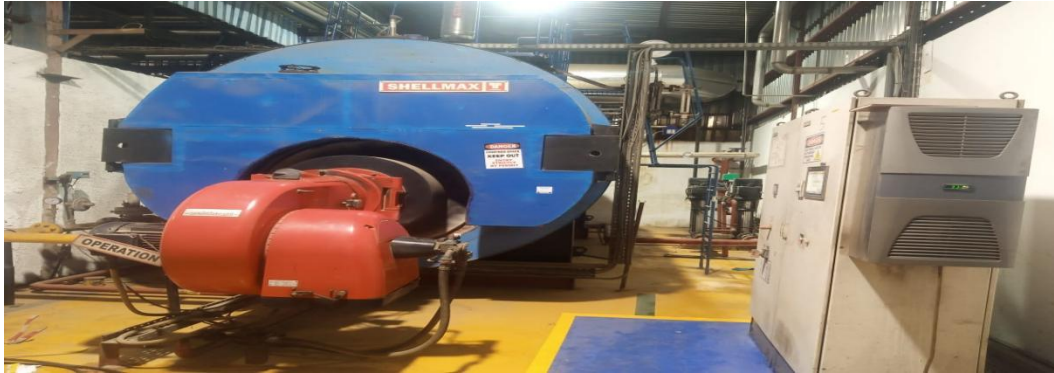
**Figure 3.2: Schematic diagram of the boiler**

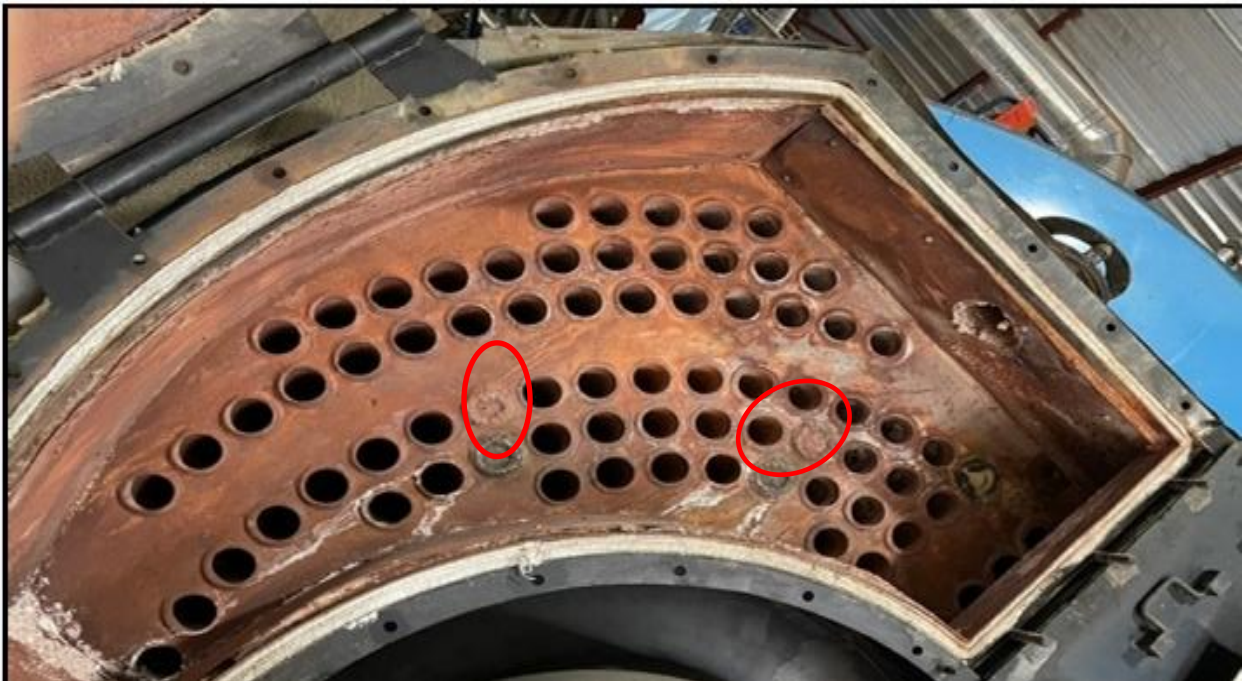
A physical check of the boiler revealed a rupture on the third-pass tube, as shown in Figure 4.1. Closer visual examination highlighted multiple pinholes around the rupture area. Additionally, particulate matter was found deposited along the path of the flue gas, on the water and also the fire sides of the tube.

**Figure 4.1: Blocked boiler tubes in the third pass.**

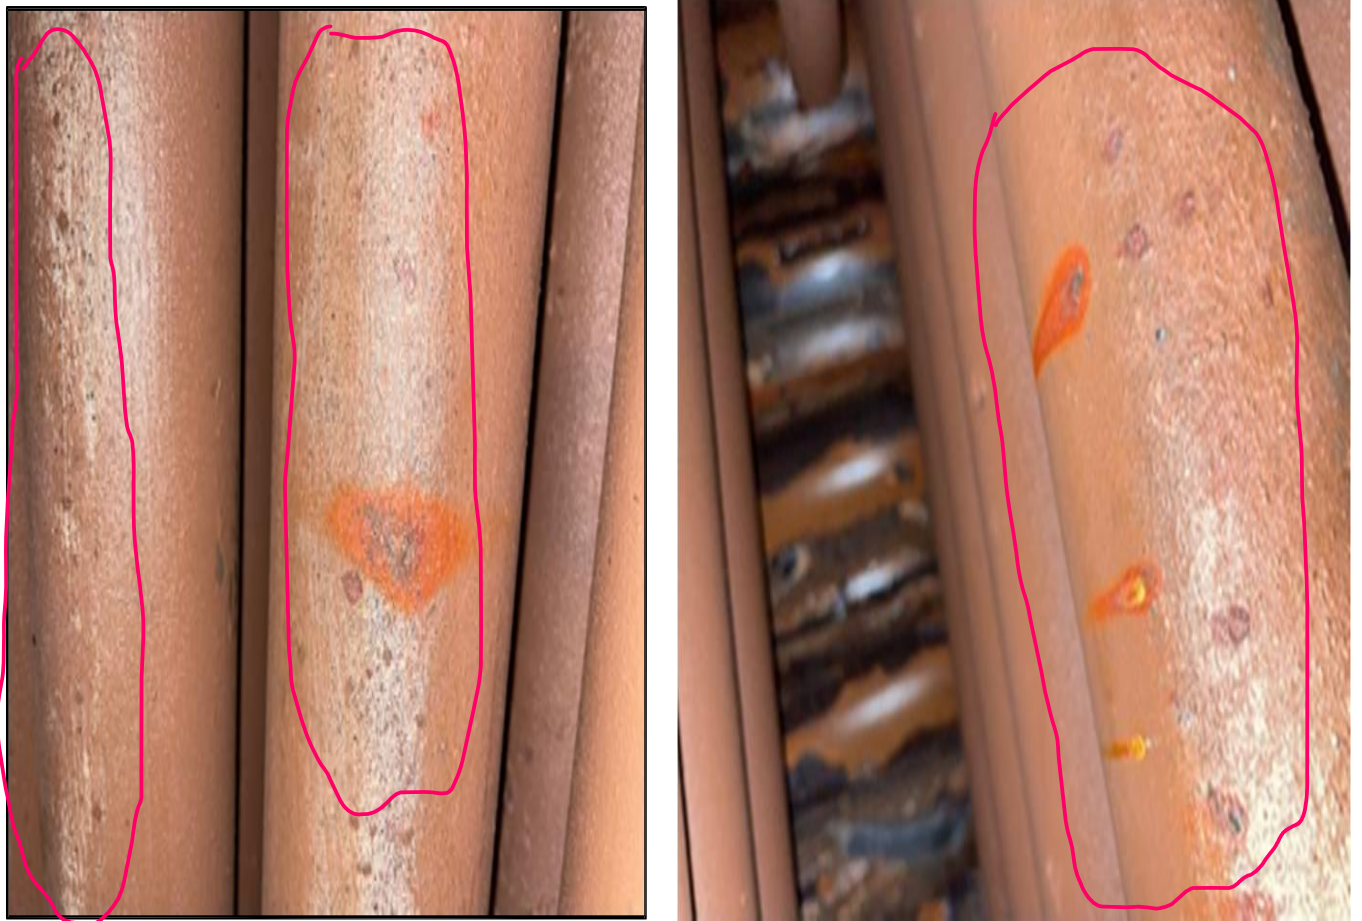
Further examination revealed significant pitting corrosion on the outer diameter (OD) and inner diameter (ID) of other tube sections, as illustrated in Figures 4.2 to 4.4. Scale formation was also observed on the tube's external surface (Figures 4.5 and 4.6)

**Figure 4.2: Pitting Corrosion in the OD of tube**

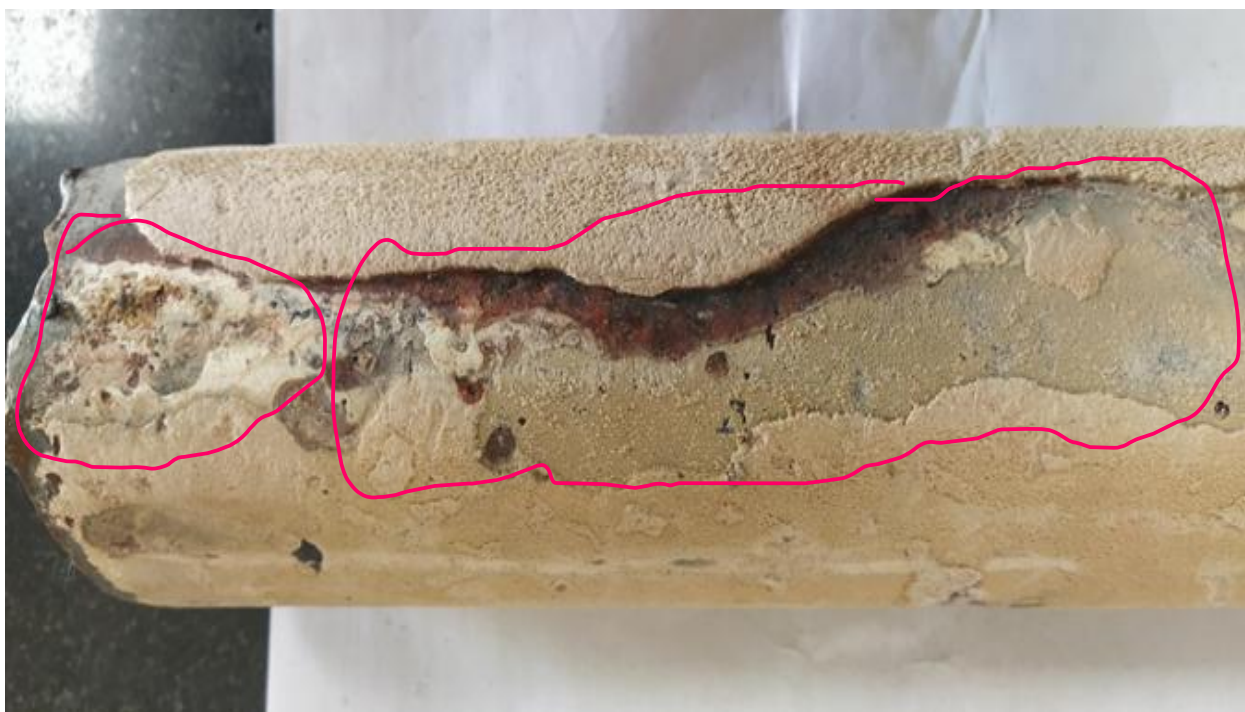
**Figure 4.5: Layered deposits observed on the boiler tube surface.**

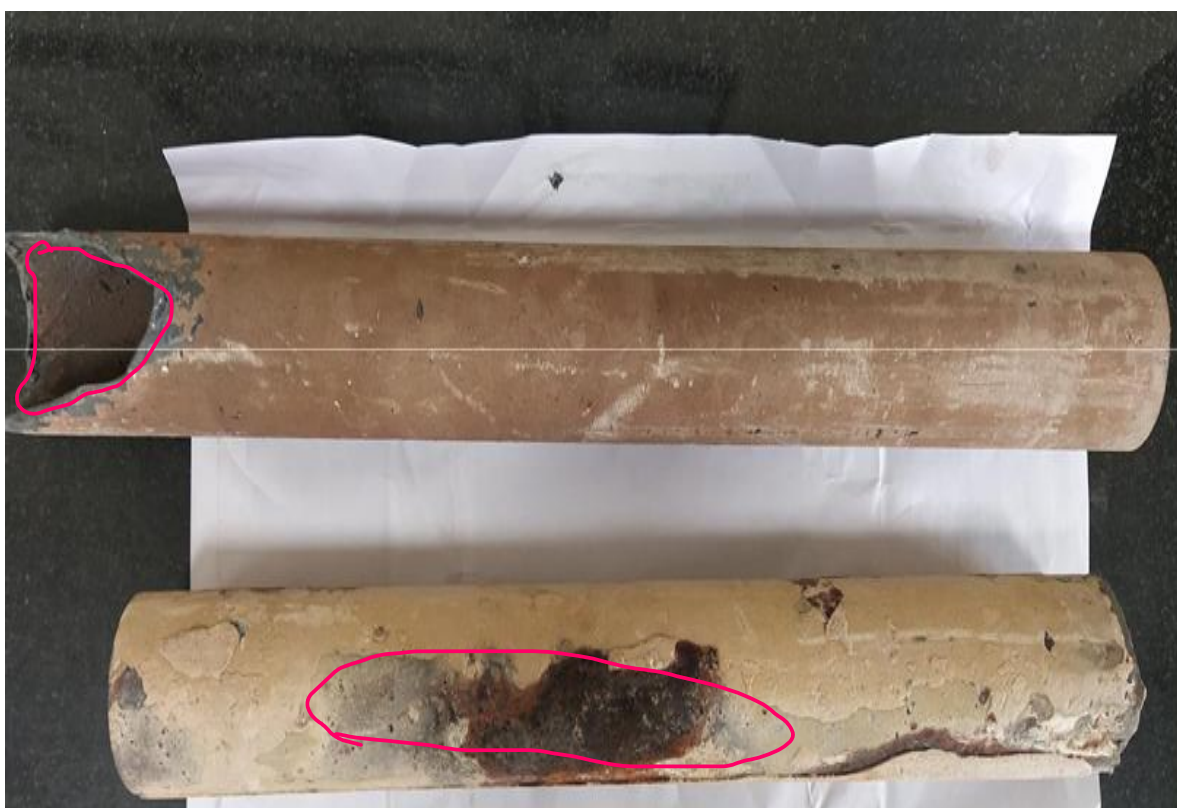
**Figure 4.6: Fractured Sample collected for further analysis**

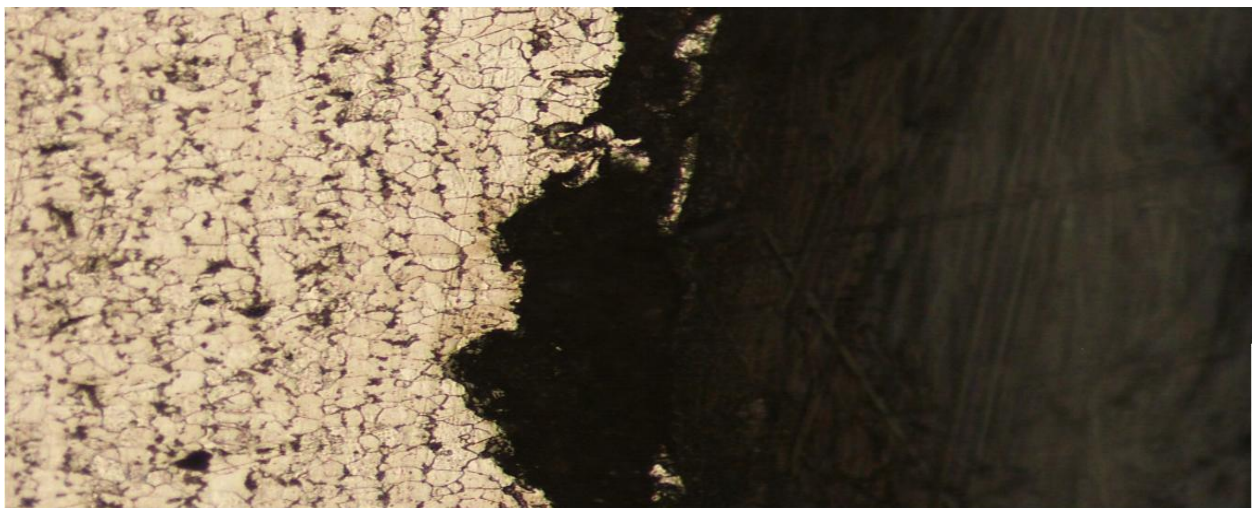
**Figure 4.9: Pitting corrosion on the OD of the affected area.**

Microstructural analysis confirmed thermal degradation of the tube, including decarburization, grain growth, and oxidation at the ID, along with pitting corrosion at the OD. These findings support the conclusion that the failure was thermally induced and aggravated by water-side corrosion.
